THE MARYLAND ZOO IN BALTIMORE

PERIMETER GATE REPORT

SEPTEMBER 2021

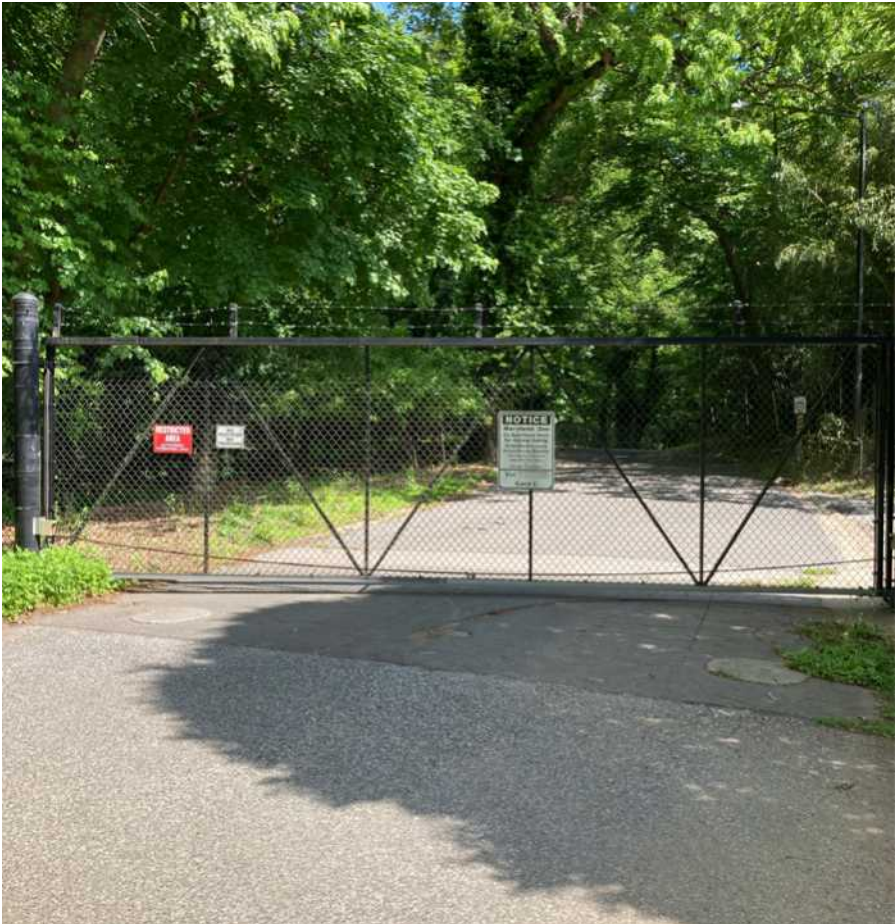
- Gate condition is good. It is a functioning automatic sliding gate that has been replaced recently.
- Call-box is outdated, new call-box necessary.
- Signs are outdated, new signage necessary.

Elevation view of automatic sliding gate.

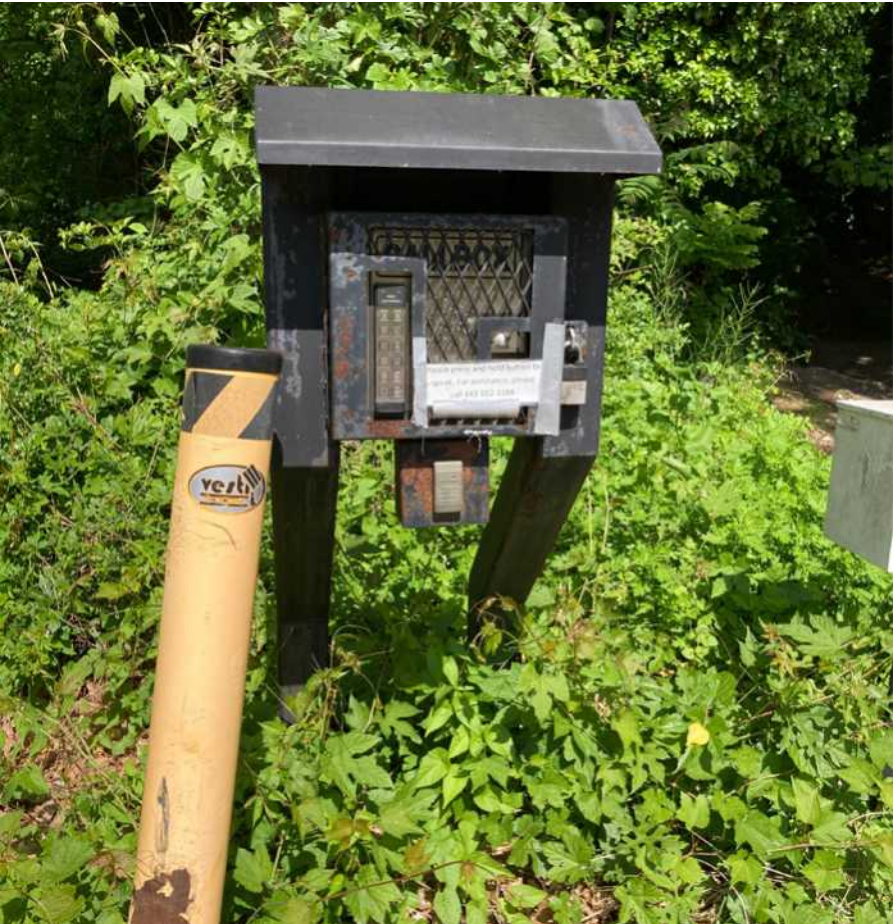
Detail view of outdated call box - rusty and in poor condition.

- ~~New sign to match "New Zoo Standard" coordinate text with Zoo.~~
- ~~Replace call box. Use existing location. Coordinate product with zoo.~~
- ~~Set at height proposed by manufacturer.~~
- New ~~asphalt~~ paving. Remove old asphalt and prepare base according to MDOT standards prior to paving.
- Remove old footer. If footer has a big base, top 24" of concrete can be removed and remaining concrete can stay below grade.
- Repair the retaining wall. Cap blocks are missing. (Refer to Photo)

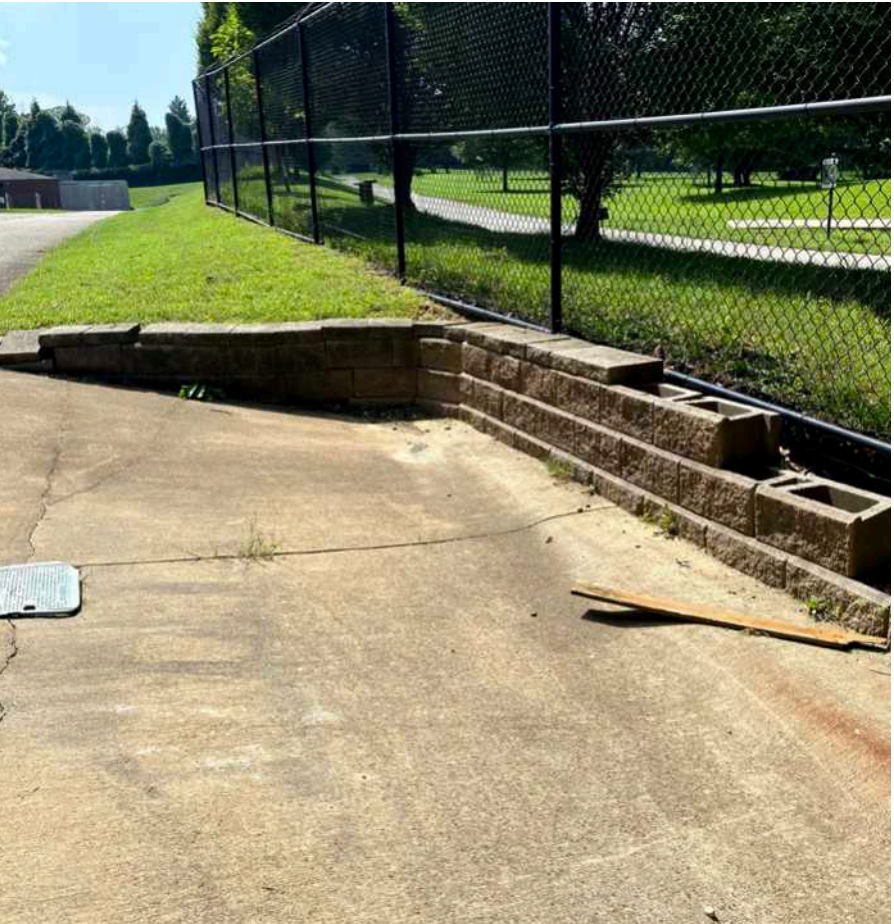
Existing retaining wall with missing cap blocks.

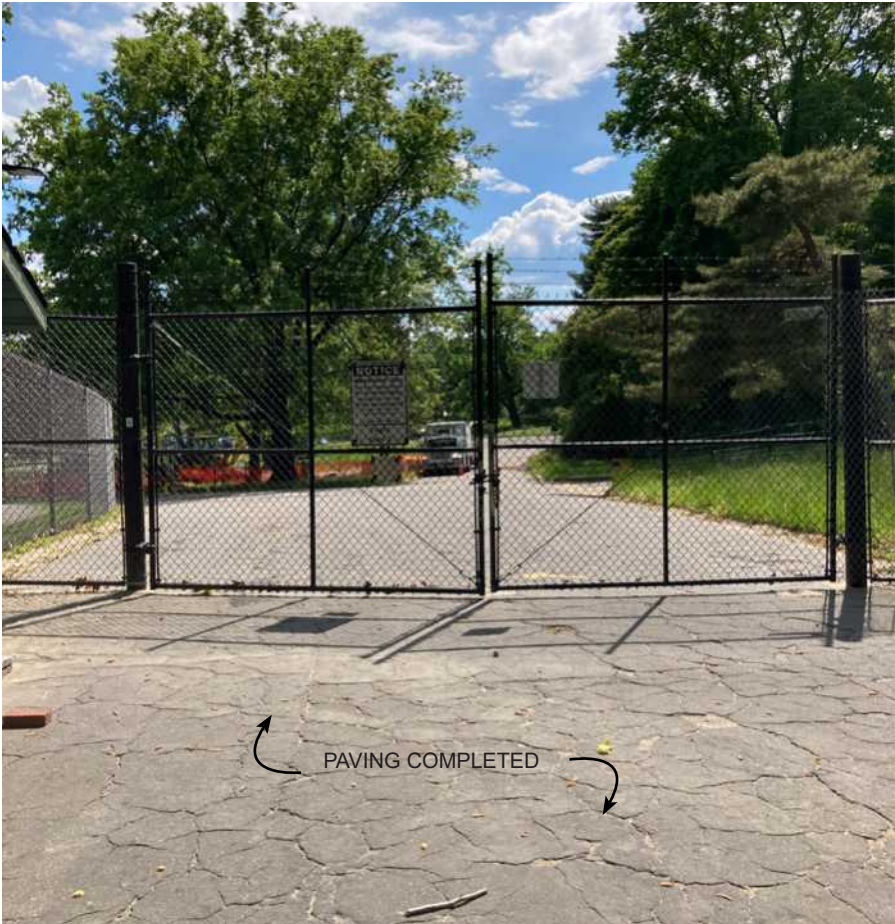
- High use gate that needs a replacement. Desiring automatic sliding gate that will slide toward the right (from interior view).
- Gate is not sturdy enough for high use.
- Needs ring loop, call box, and FOB reader.
- Signs are outdated, new signage necessary.

Elevation view of double swing manual gate needing full replacement.

- Remove old gate and replace with 20'-0" slide gate with electronic operator. Construct according to specifications provided at the end of this report.
- OR use 20'-0" by 8'-0" vertical pivot gate (Refer to Photo)

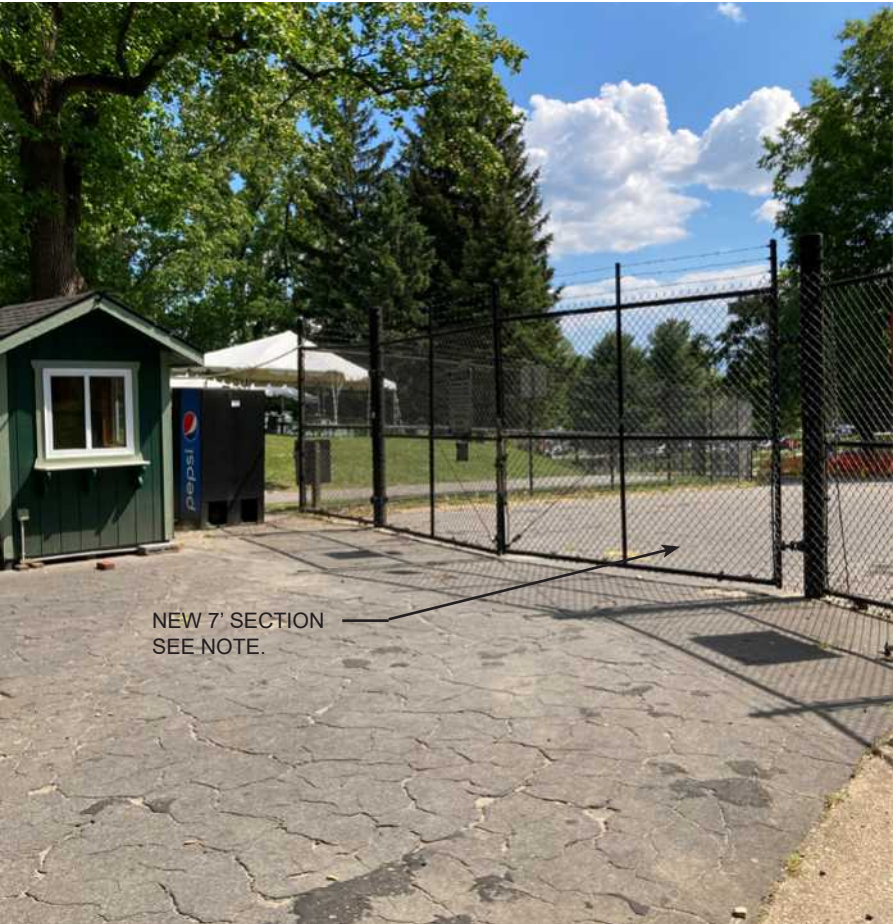
Additional elevation view, with ticketing hut.

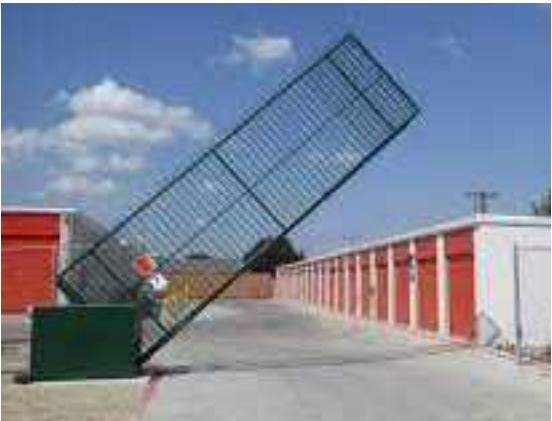
Vertical pivot gate

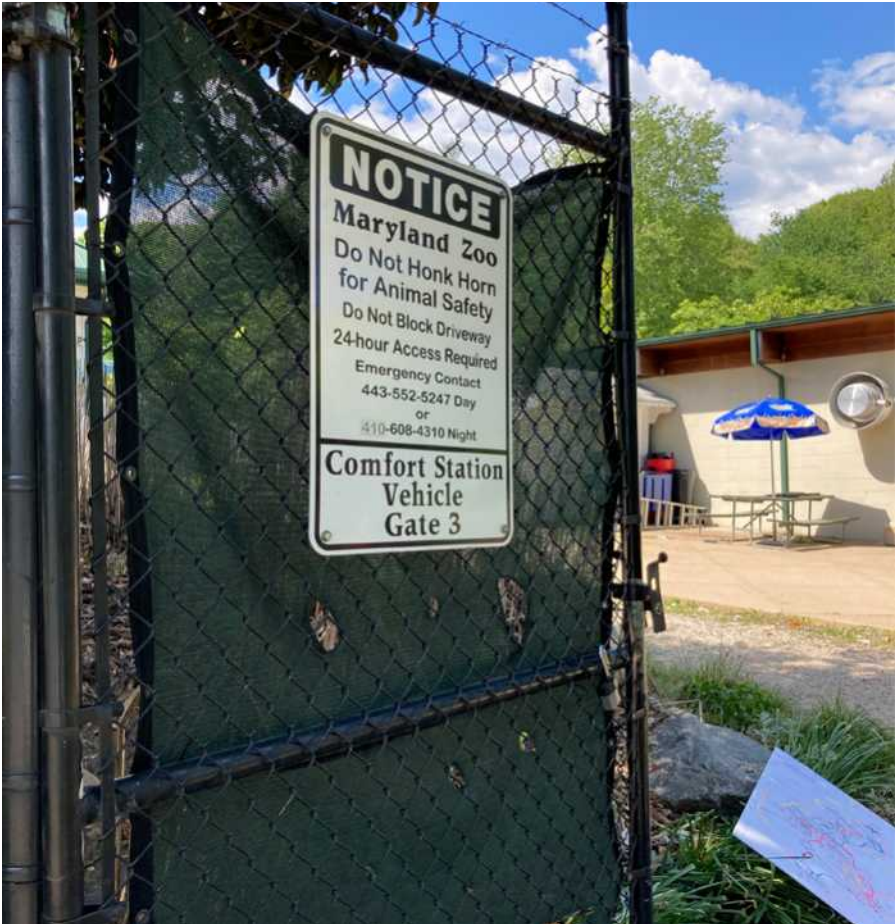
Close view of Gate 3, outdated sign.

- ~~New sign to match "New Zoo Standard" coordinate text with Zoo.~~
- Remove existing gate and replace with 10'-0" manual swing gate constructed according to specifications provided at the end of report. All gate pots and hardware should be completely replaced.
- New ~~asphalt~~ paving. Remove old asphalt and prepare base according to MDOT standards prior to paving.

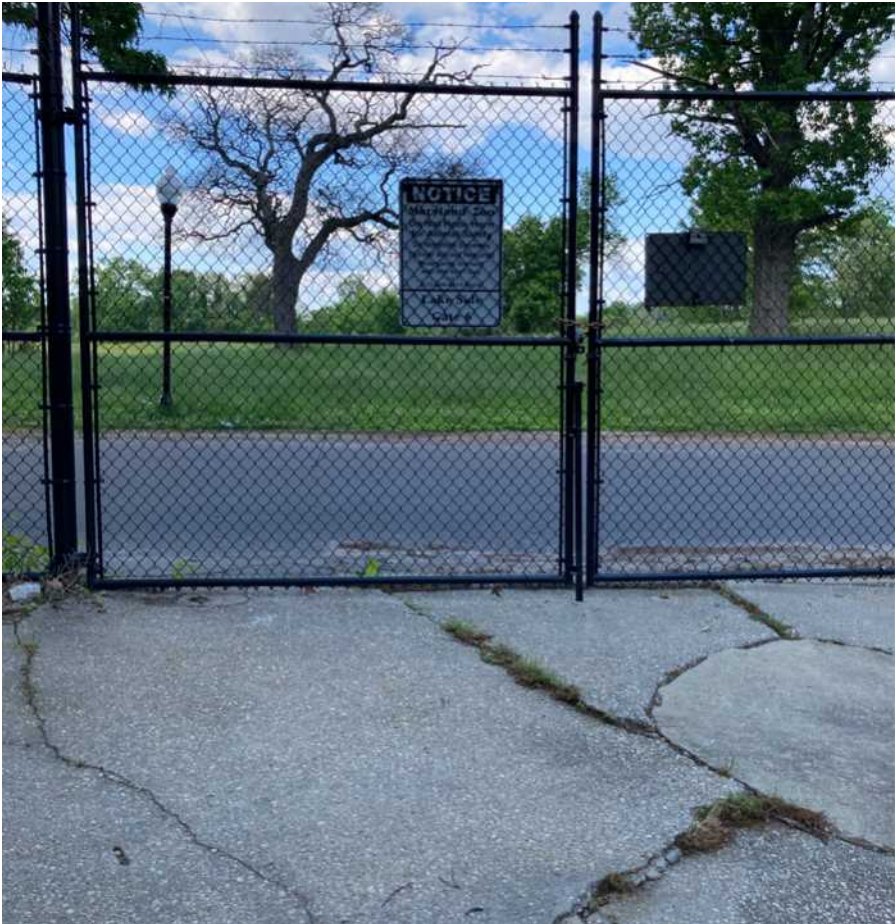
Elevation of Gate 6, outdated sign.

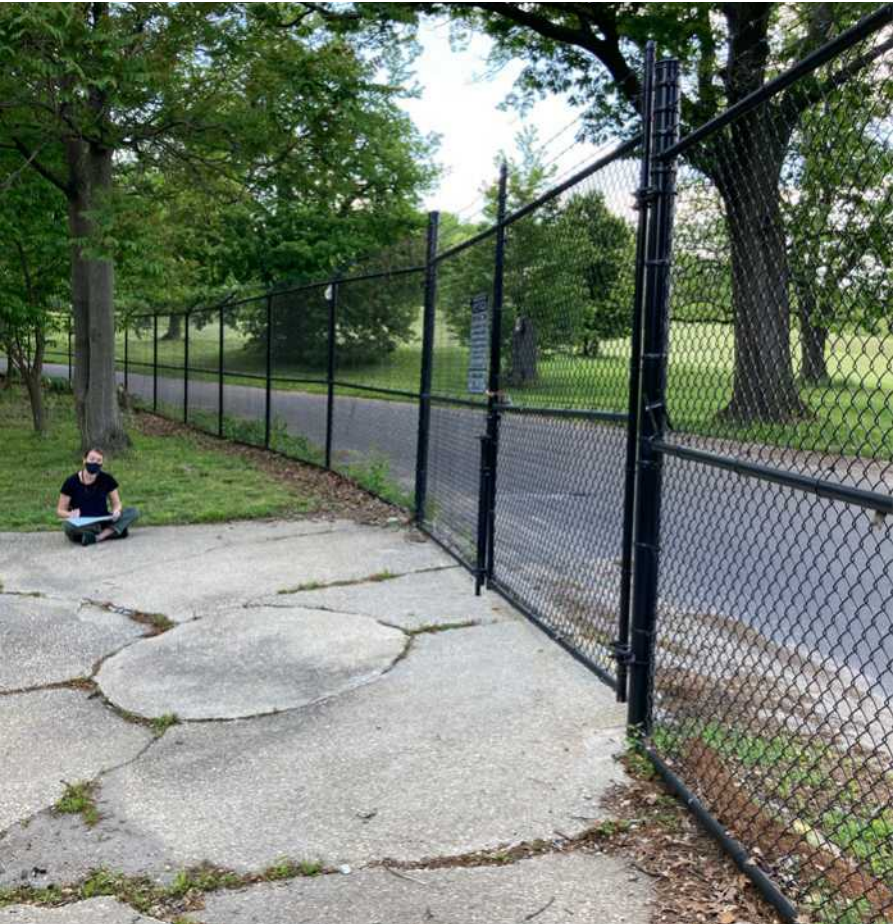
- Paving is cracking and uneven, needs major repaving.
- Please cut curb and repave area interior to the fence.

View of paving at Gate 6, broken and uneven.

Concrete not asphalt

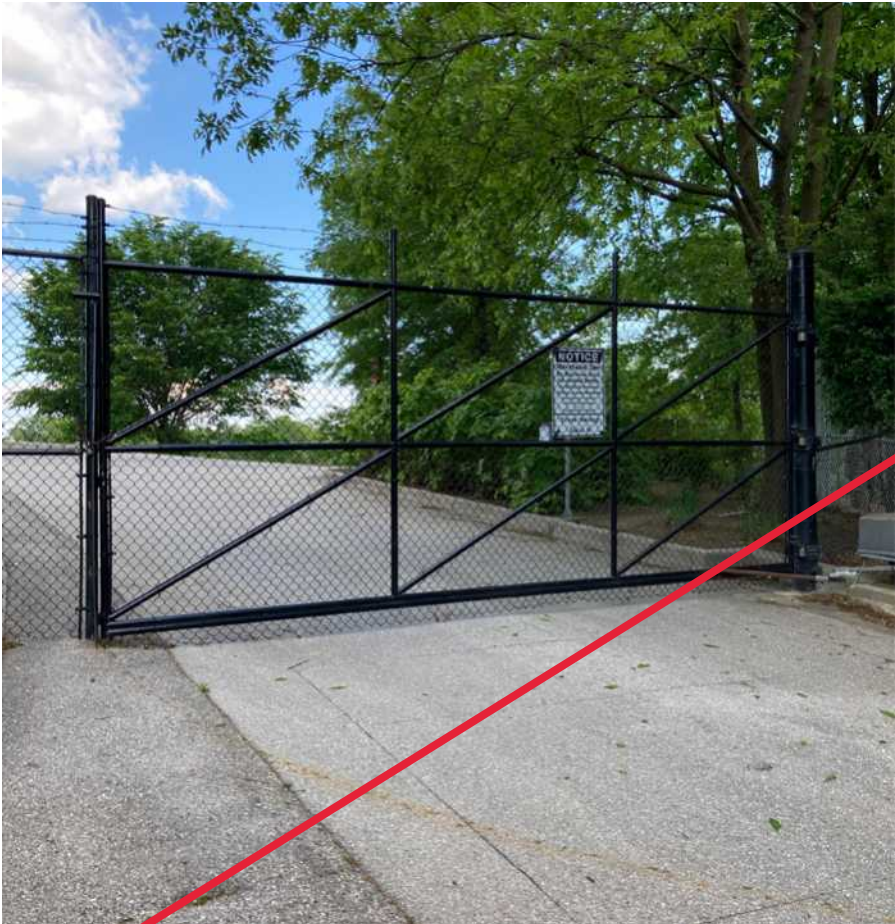
Elevation of Gate 8, recently replaced.

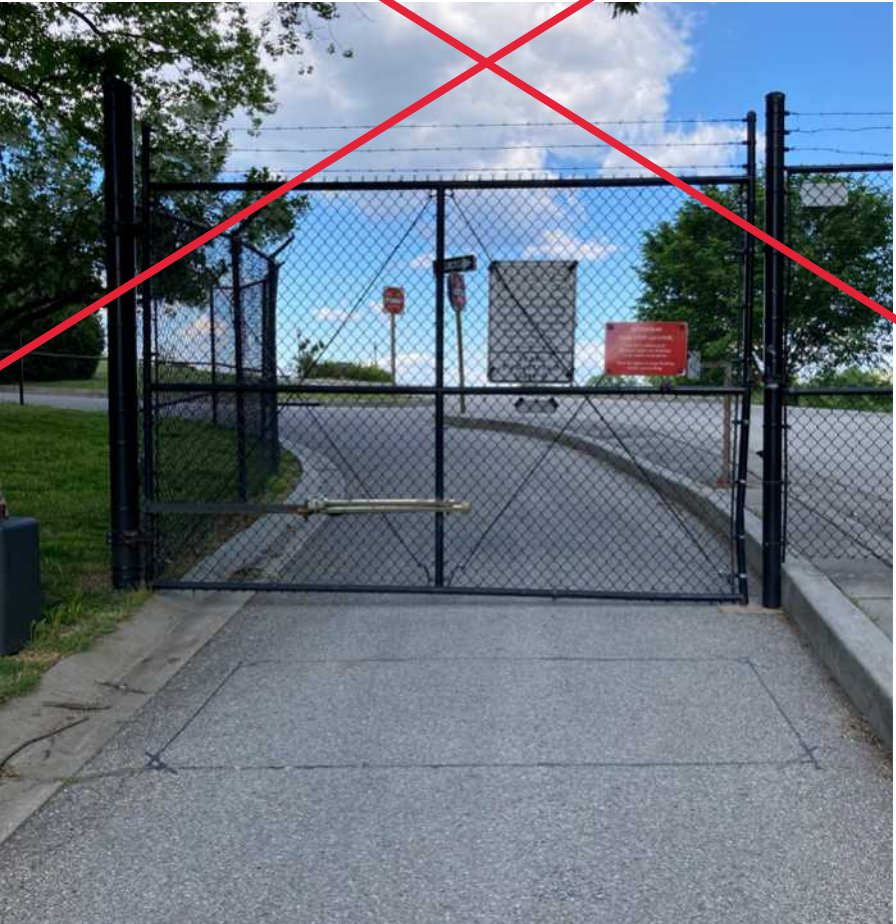
Elevation of Gate 9, recently replaced.

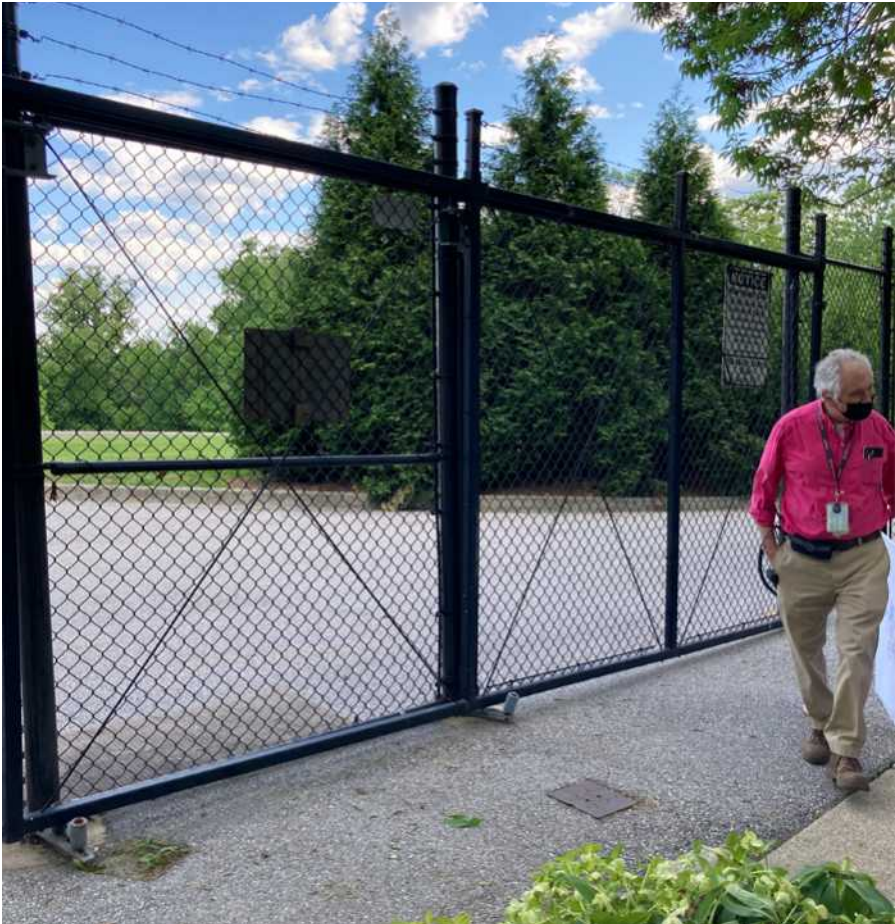
- **Gate 10**
 - Signs are outdated, new signage necessary.
 - The manual slider has a broken roller.
 - Wheel missing from gate slider.
- **Gate 11**
 - Electric coupling is broken.
 - Signs are outdated, new signage necessary.
 - Call box is not available on site, but the item is desired.

Elevation view of Gate 10, outdated sign.

- ~~New sign to match "New Zoo Standard" coordinate text with Zoo.~~
- Gate 10:** Replace broken roller on manual slide gate. Coordinate product with zoo, prepare using manufacturer specifications.
- Gate 11:** Repair electric coupling mechanism. Use specifications provided by manufacturer.
- ~~Add call box. Coordinate placement and product with zoo. Set at height proposed by manufacturer.~~

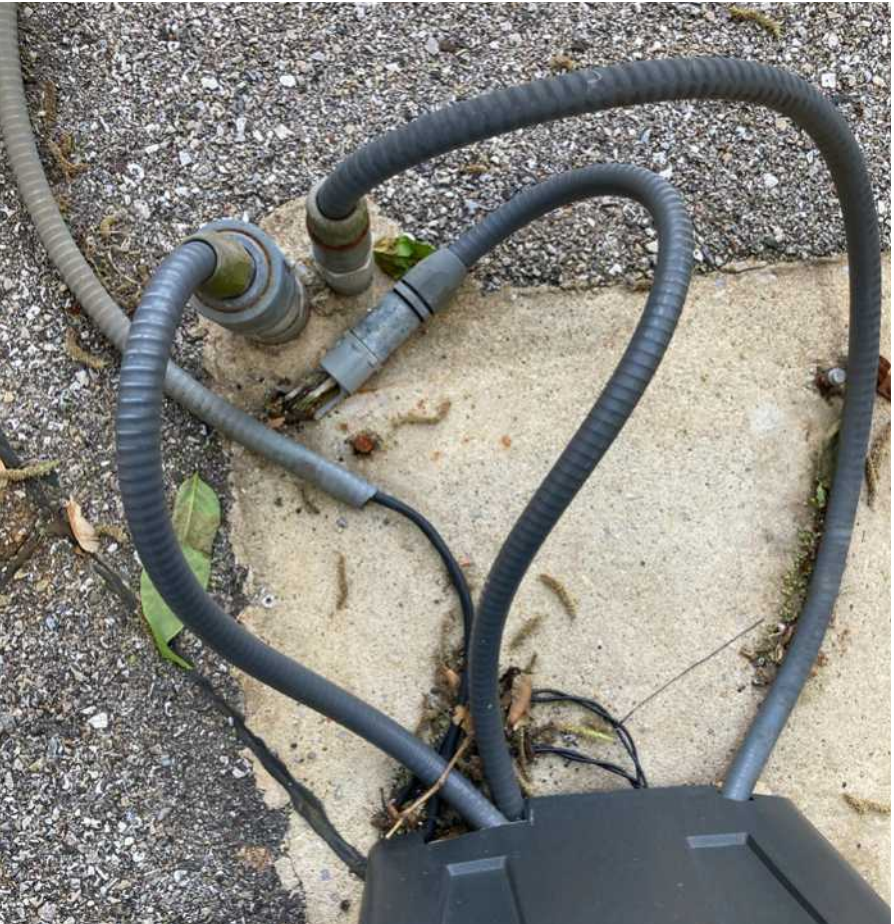
Gate 11 electrical cables are damaged.

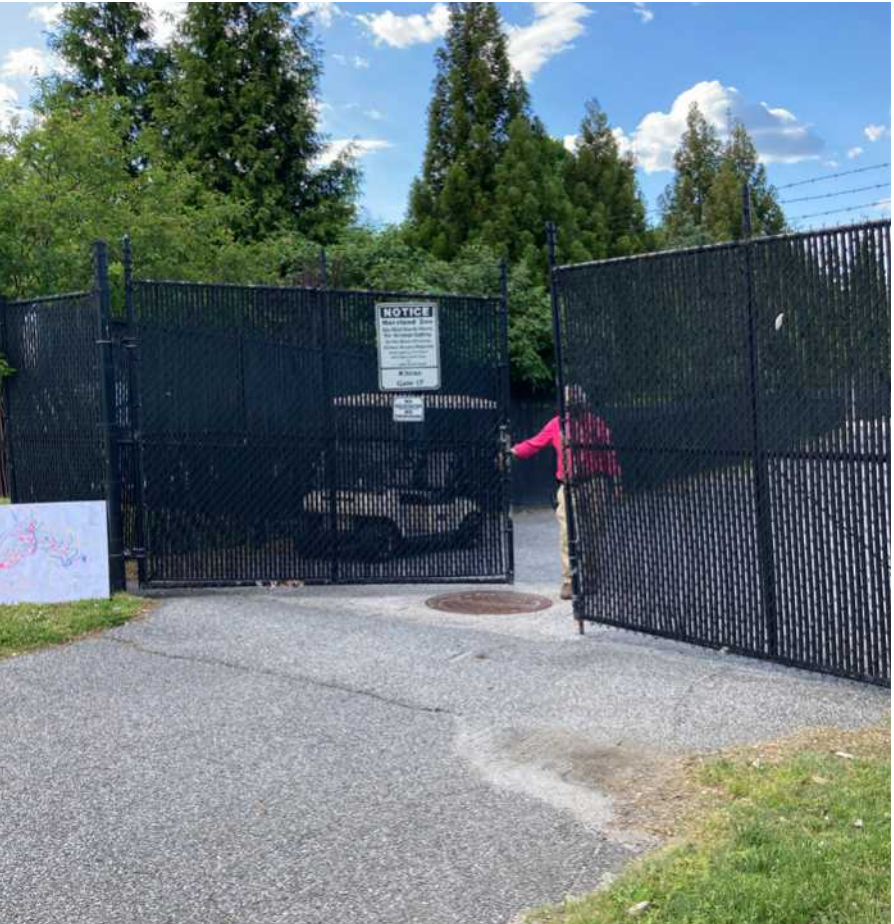
- Current gate in poor condition due to frequent use. Gate needs total rebuild.
- Signs are outdated, new signage necessary.

Perspective view of Gate 17, outdated sign to be replaced.

- ~~New sign to match "New Zoo Standard" coordinate text with Zoo.~~
- Replace with black vinyl coated double swing gate, 20 ft in length.
Rebuild gate according to zoo standard specifications.

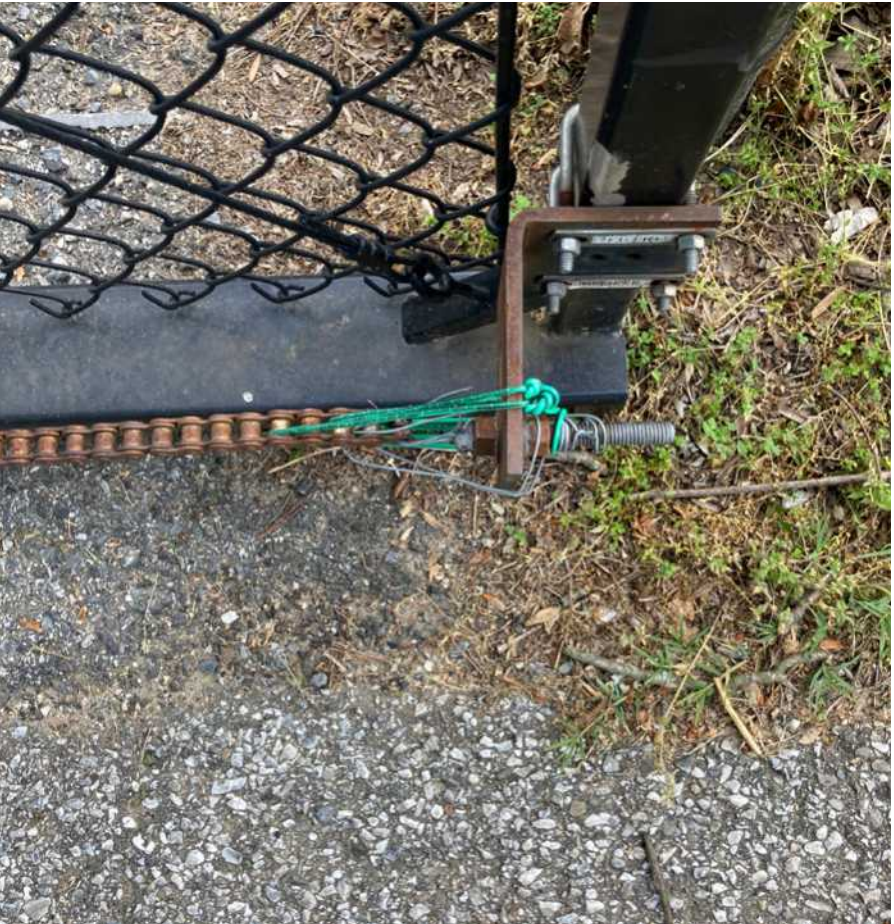
- Chain plate is broken (see image bottom right).
- Signs are outdated, new signage necessary.
- Electric mechanism needs to be repaired.
- Confirm gate has miller edge.

Broken chain-plate on Gate 18.

- ~~New sign to match "New Zoo Standard" coordinate text with Zoo.~~
- Replace chain plate. Construct replacement using manufacturer specifications. Coordinate with zoo for product information.
- Confirm gate has miller edge. If gate does not, add miller edge to gate.
- Electric gate mechanism broken. Repair according to manufacturer specifications. Coordinate product information with zoo.

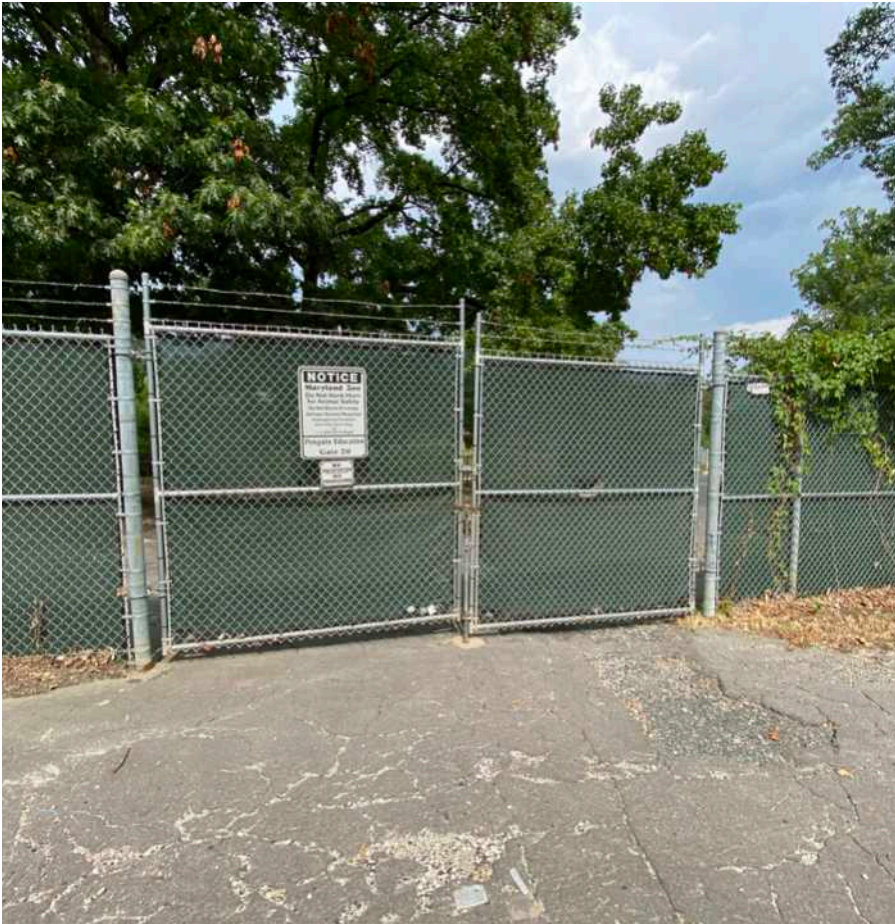
- Gate condition poor for usage type. Rebuild to slide gate is necessary.
- Signs are outdated, new signage necessary.

Interior view of Gate 20.

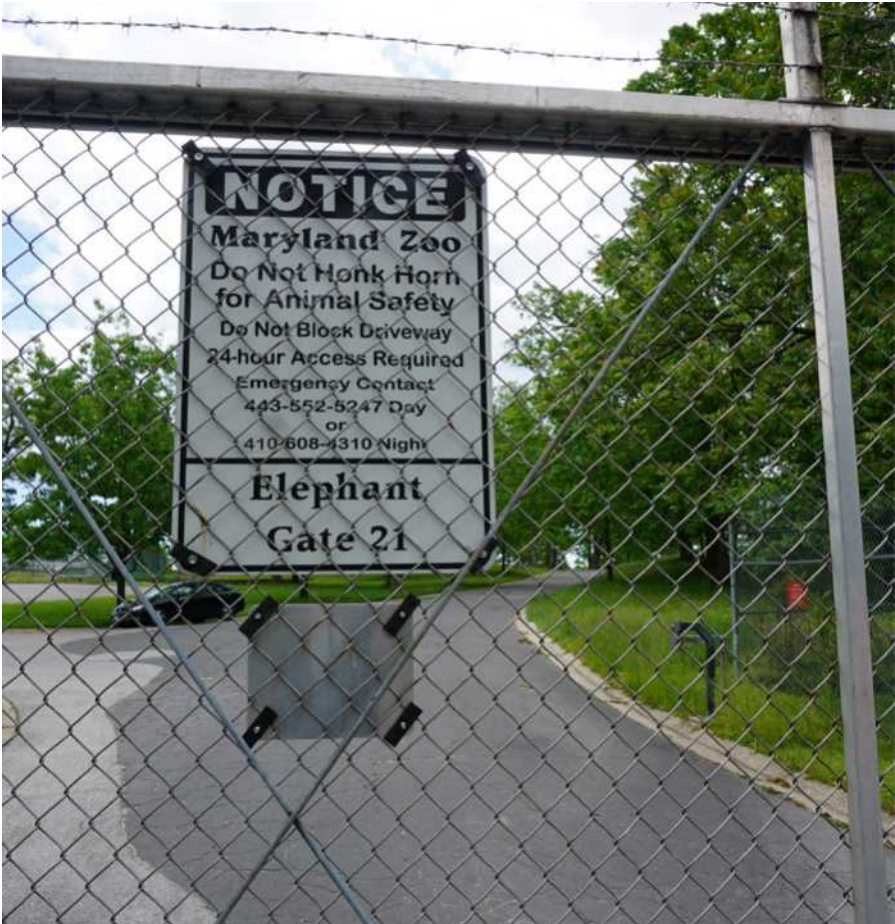
Close view of Gate 21, outdated sign.

- ~~New sign to match "New Zoo Standard" coordinate text with Zoo.~~
- Replace guide wheel on gate. Coordinate product with zoo.
- Construct NEENAH 14" drain system. Use manufacturer specifications.
- ~~Add call box. Coordinate locations with zoo. Coordinate product with zoo. Set at height proposed by manufacturer.~~

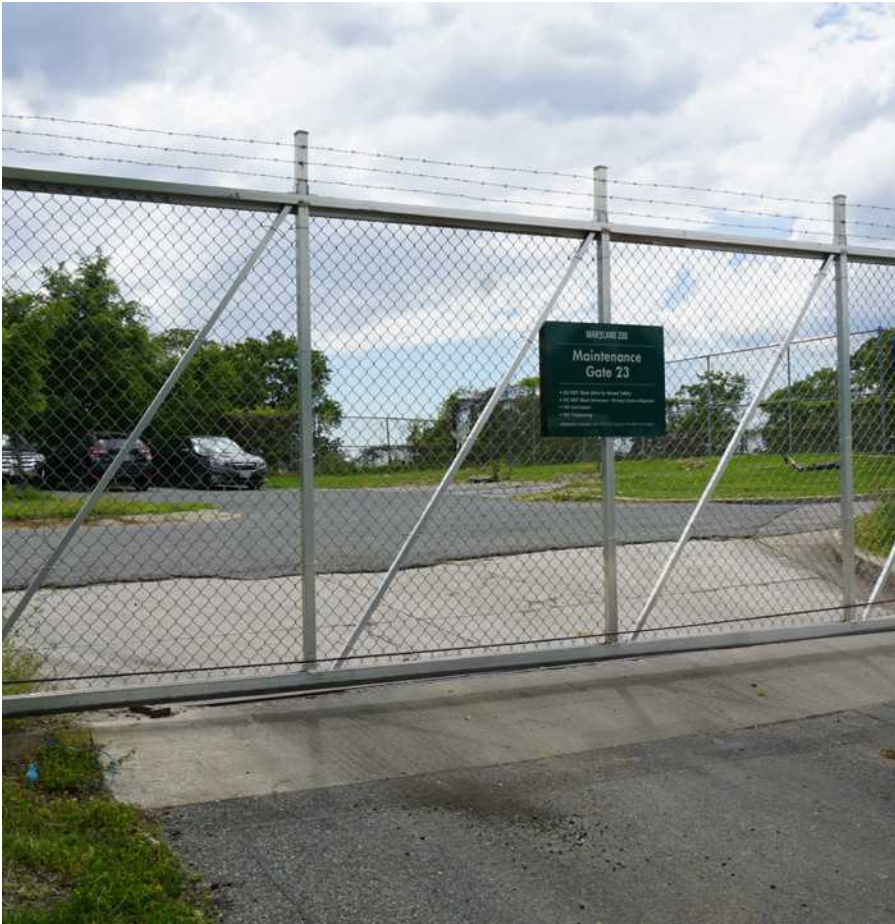
Elevation of slide Gate 23.

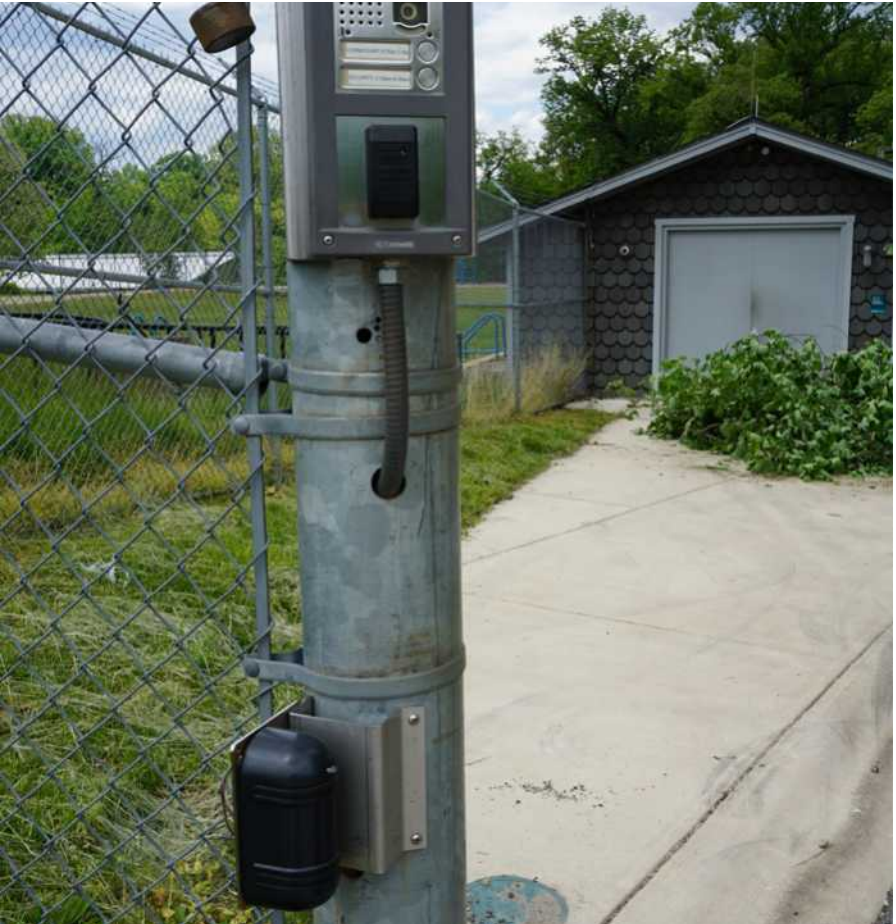
Call box to be replaced.

- ~~Replace call box. Use existing location. Coordinate product with zoo.~~
~~Set at height proposed by manufacturer.~~
- Replace asphalt in damaged area. Remove old asphalt and prepare base according to MDOT standards prior to paving.
- One segment of NEENAH drain is broken and needs replacement. Remove existing broken segment and replace according to manufacturer specifications.

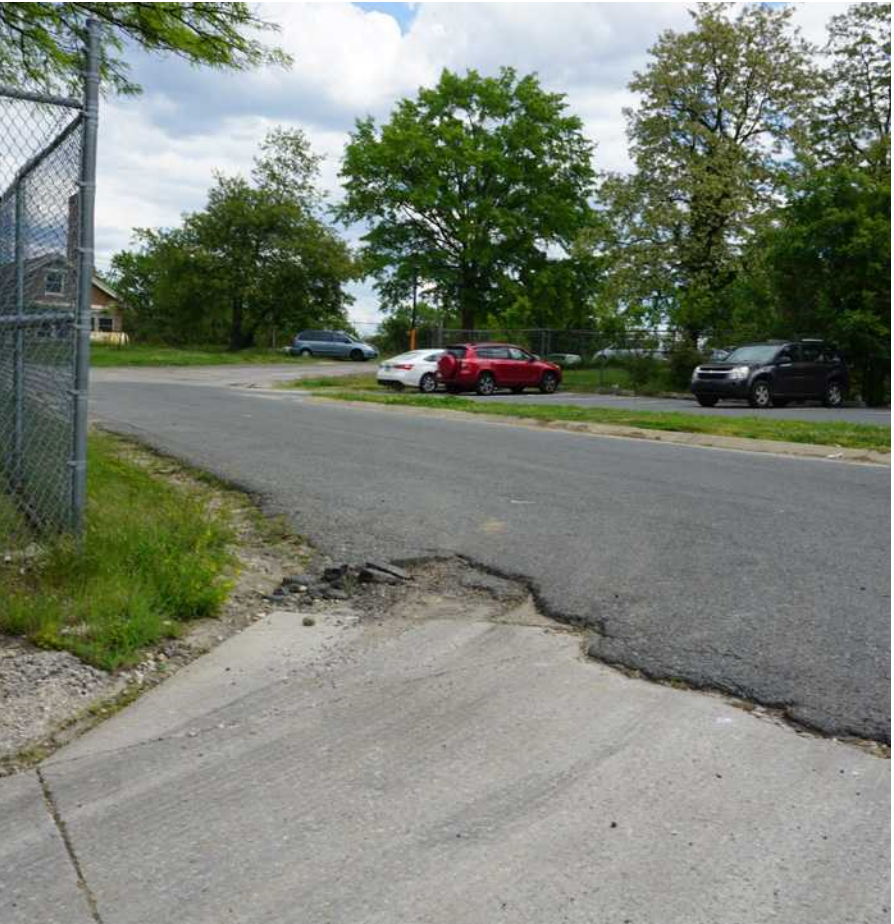
- Need patch in NEENAH drain, 1 piece 30in x 12in.
- Paving needs patching, cracked just exterior to gate.

Damaged paving that needs patching.

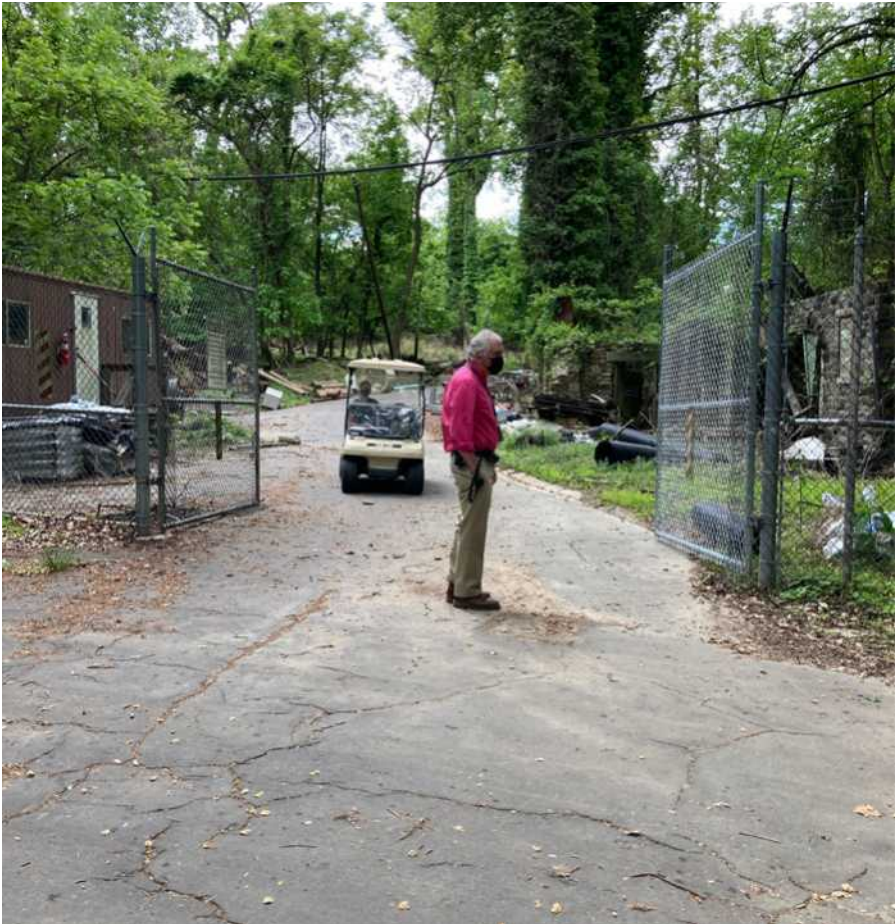
- Site has extensive ruderal growth and leaf debris build up.
- Possible candidate for leveling curb.
- Surrounding fencing barbed wire has deteriorated 40 ft to the left of gate (from interior view).

Gate 24, open. Ground slopes and may need a leveling curb.

- ~~New sign to match "New Zoo Standard" coordinate text with Zoo.~~
- Add drop pin to gate. Drop pin should be constructed according to zoo standard specifications in this report.
- Barbed wire on either side of gate should be replaced. Remove existing 40'-0" segment next to gate and replace according to zoo standard specifications.
- Overgrown vegetation should be completely removed within a 20'-0" radius of gate.

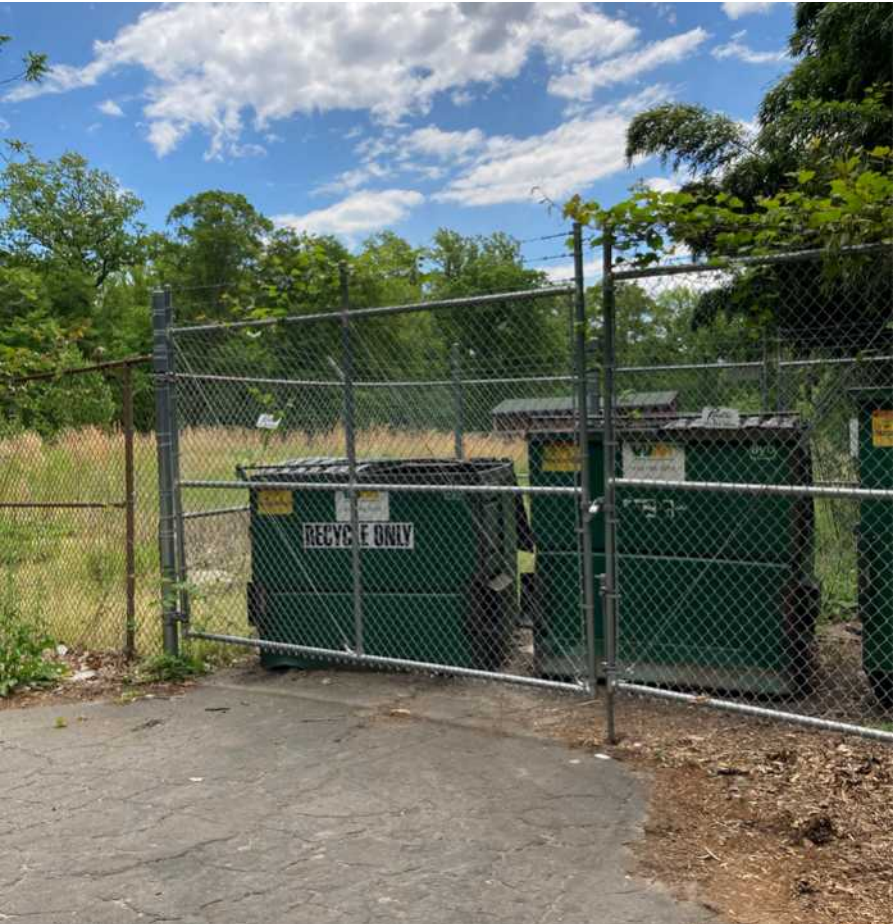
Top left gate hinge needs to be replaced.

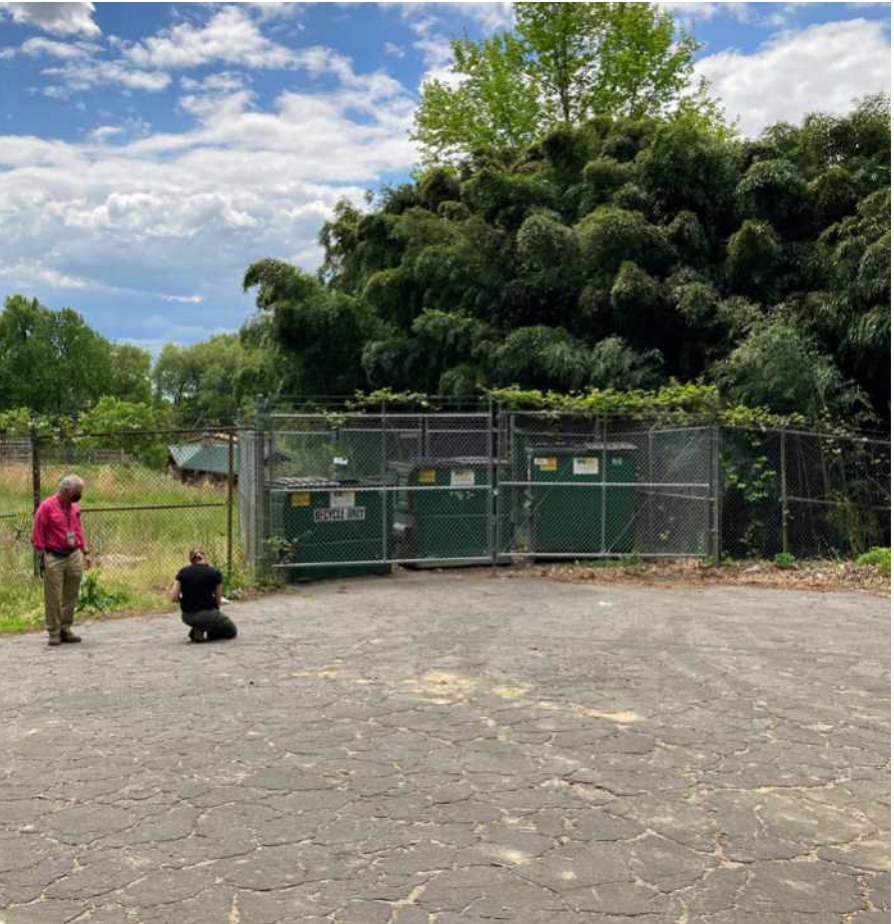
Elevation view of Gate 27.
