THE MARYLAND ZOO IN BALTIMORE

PERIMETER GATE REPORT

SEPTEMBER 2021

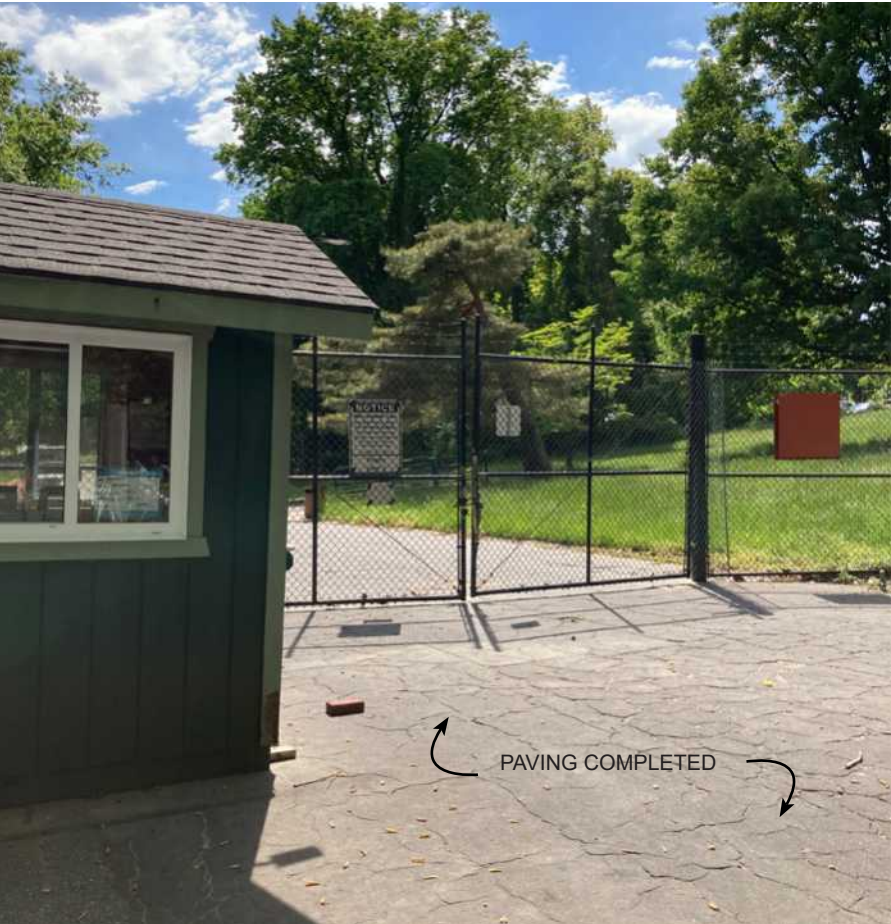
Close view of ticketing hut.

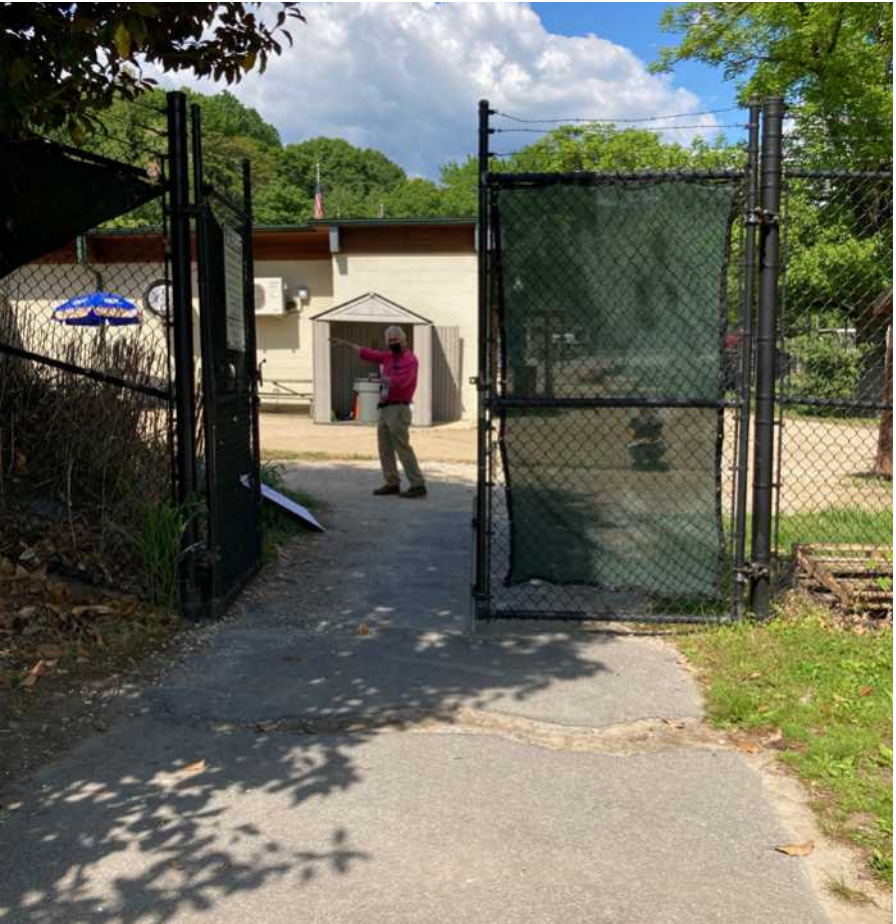
- Gate in poor condition and replacement with single leaf swing gate is desired.
- Signs are outdated, new signage necessary.

Elevation of double swing Gate 3.

- ~~New sign to match "New Zoo Standard" coordinate text with Zoo.~~
- Remove existing gate and replace with 10'-0" manual swing gate constructed according to specifications provided at the end of report. All gate pots and hardware should be completely replaced.
- New ~~asphalt~~ paving. Remove old asphalt and prepare base according to MDOT standards prior to paving.

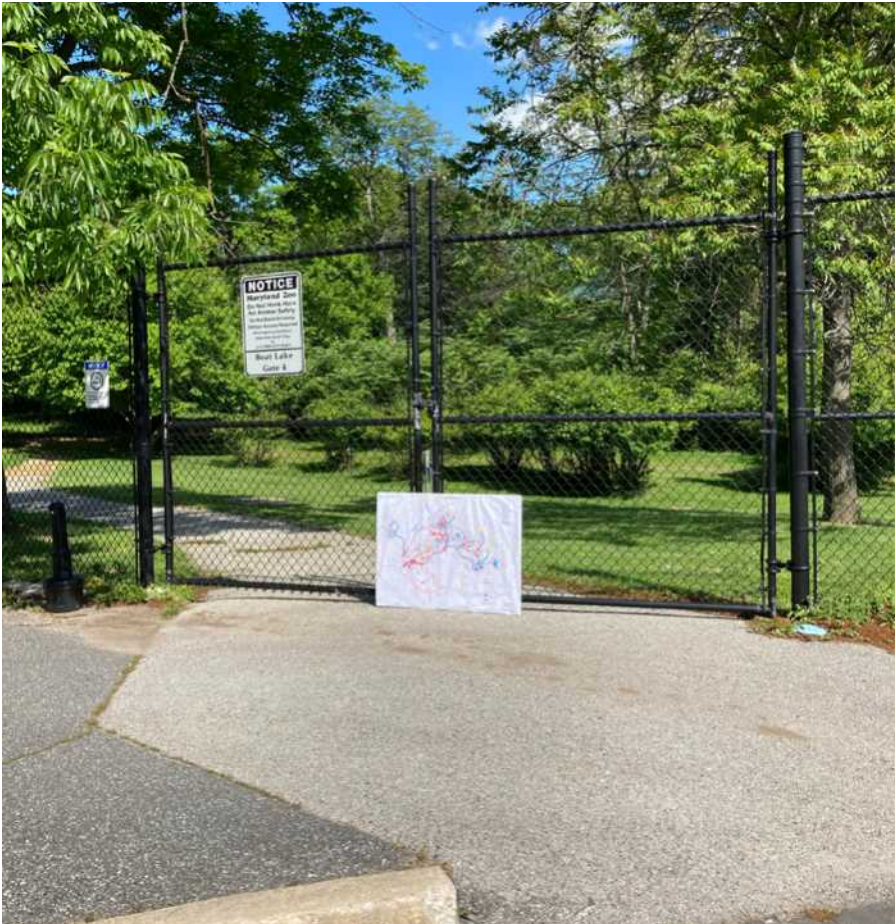
Elevation view of Gate 4, outdated sign.

- ~~New sign to match "New Zoo Standard" coordinate text with Zoo.~~

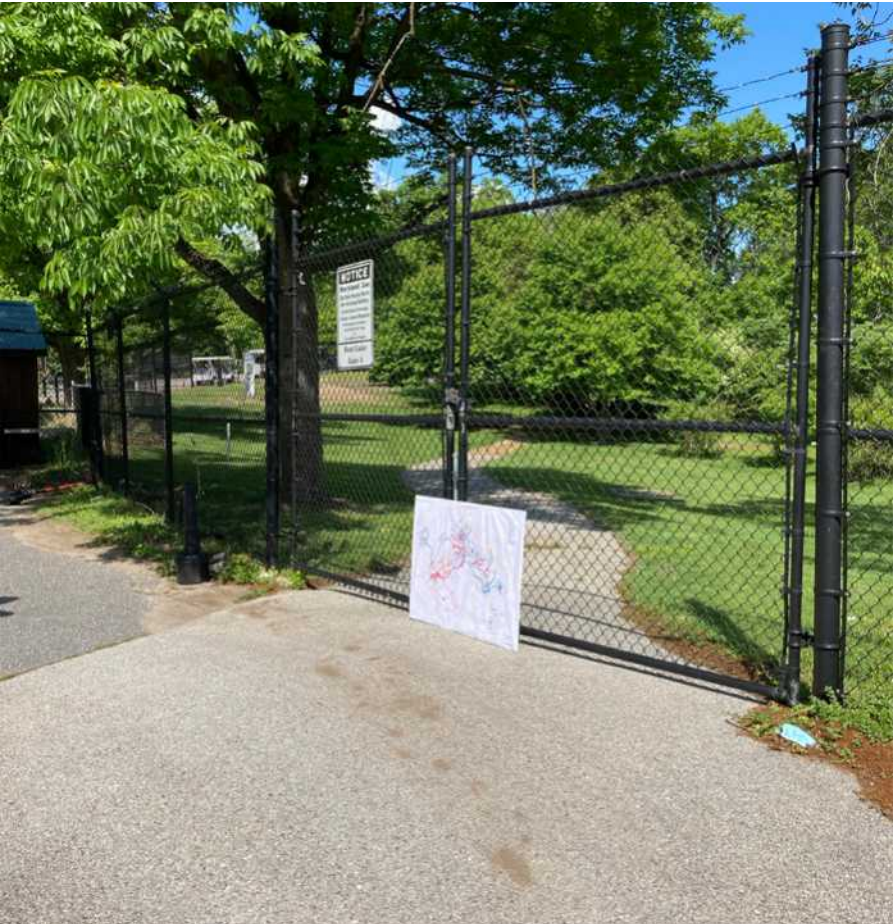
- Gate is in good condition.
- Signs are outdated, new signage necessary.

Elevation of double swing Gate 4.

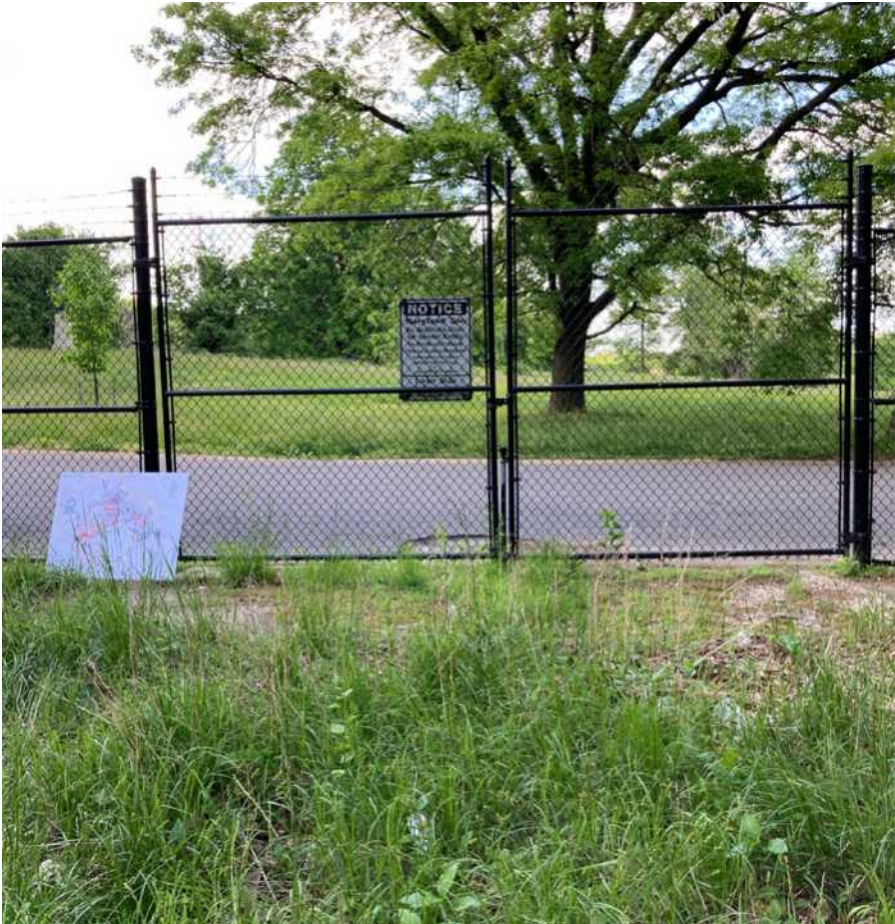
Close view of vegetation at Gate 5.

- ~~New sign to match "New Zoo Standard" coordinate text with Zoo.~~
- Reset gate so that it sits 2 inches above gravel of pavement.
- Site should be cleaned of vegetation. Remove overgrown grass and vegetation within 20 ft of gate.

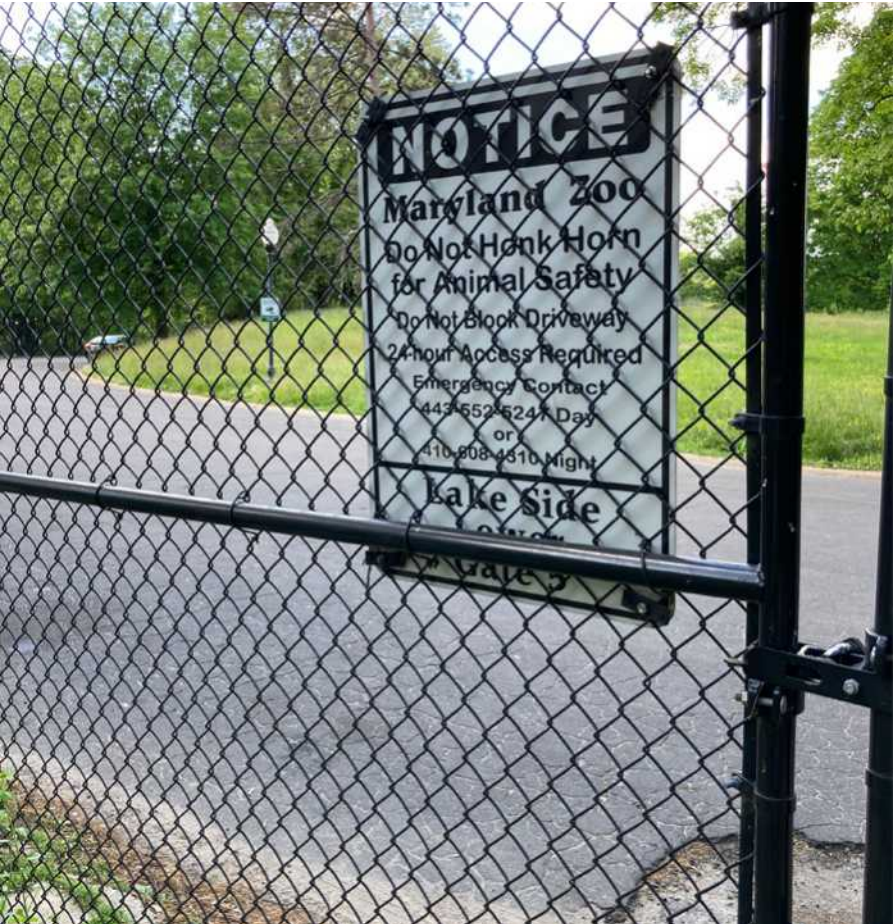
Close view of outdated sign at Gate 5.

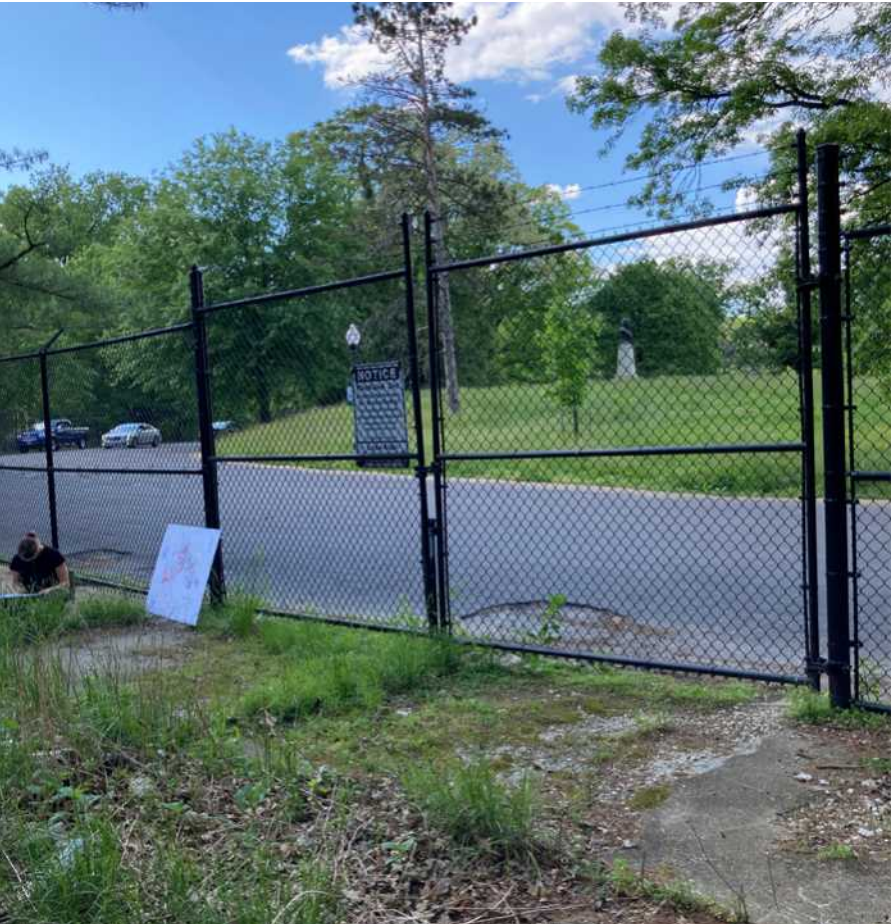
Perspective view at Gate 5, overgrown vegetation below.

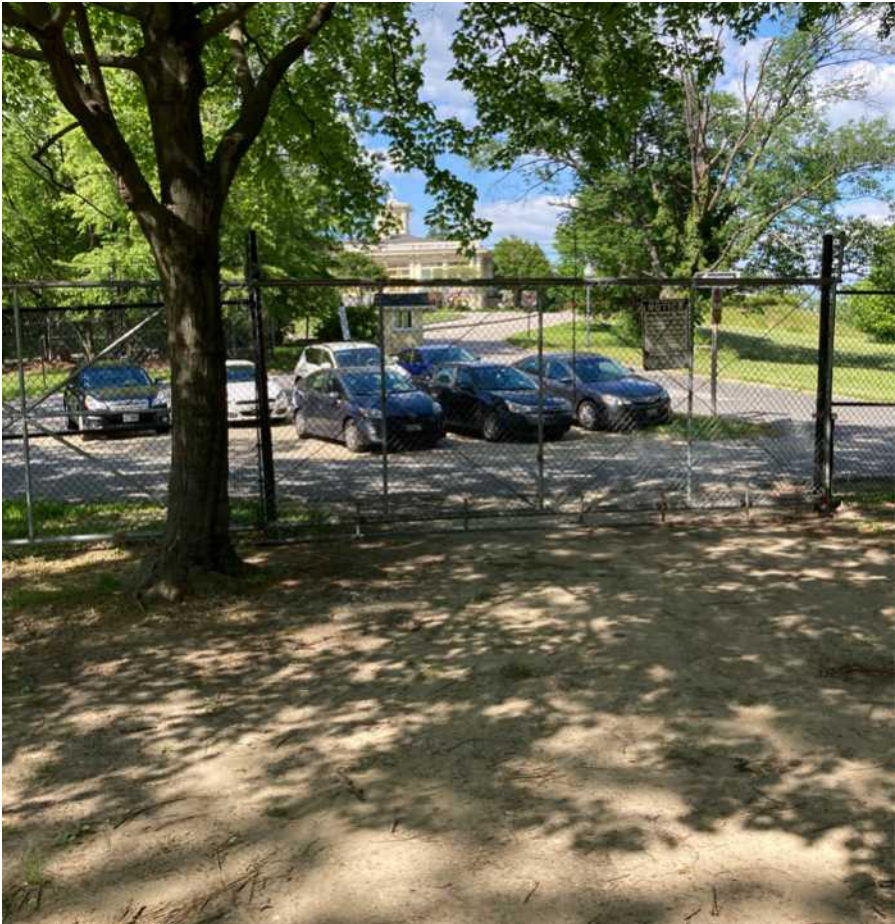
- Total repaving necessary.
- Maple tree located interior left of gate (from interior view). Tree should be protected during construction.
- Ginkgo biloba needs to be protected, located interior right of gate (from interior view).
- Remove footers from old gate posts.

Site view of Gate 7, with tree to protect.

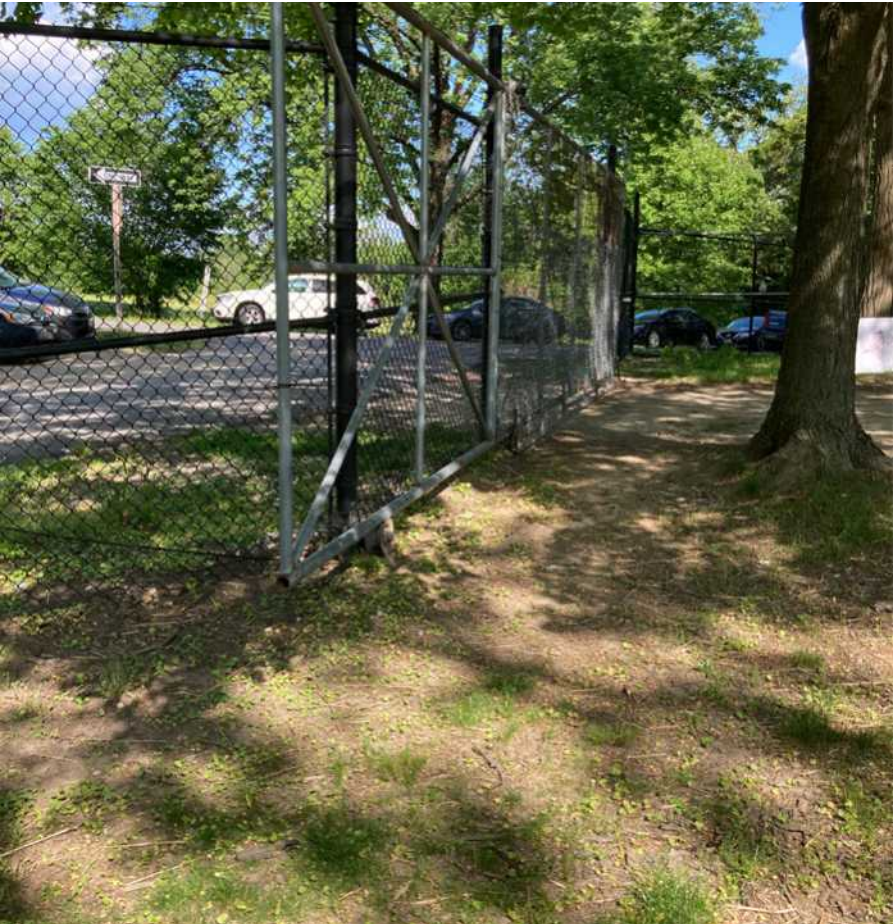
- Gate condition poor. Manual sliding gate, total replacement. Gate should be replaced with electric sliding gate. End posts of old gate should be removed.
- Signs are outdated, new signage necessary.

Elevation of slider at Gate 7.

- ~~New sign to match "new zoo standard" coordinate text with zoo.~~
- New ~~asphalt~~ paving. Remove old asphalt and prepare base according to MDOT standards prior to paving.
- ~~For new paving below gate, use grass pave. Prepare according to manufacturer instructions.~~
- Remove old gate and replace with 20'-0" slide gate with electronic operator. Construct according to zoo specifications provided at the end of this report. Add electronic gate operator to the left (interior view).

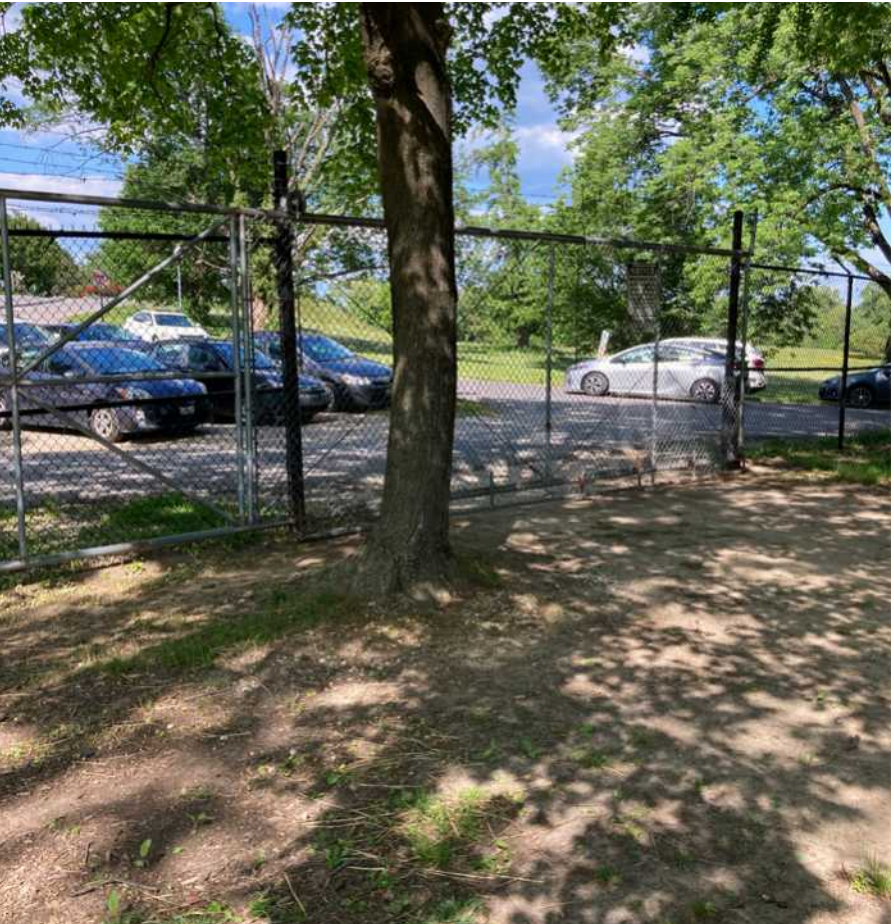
Tree to be protected at Gate 7 site.

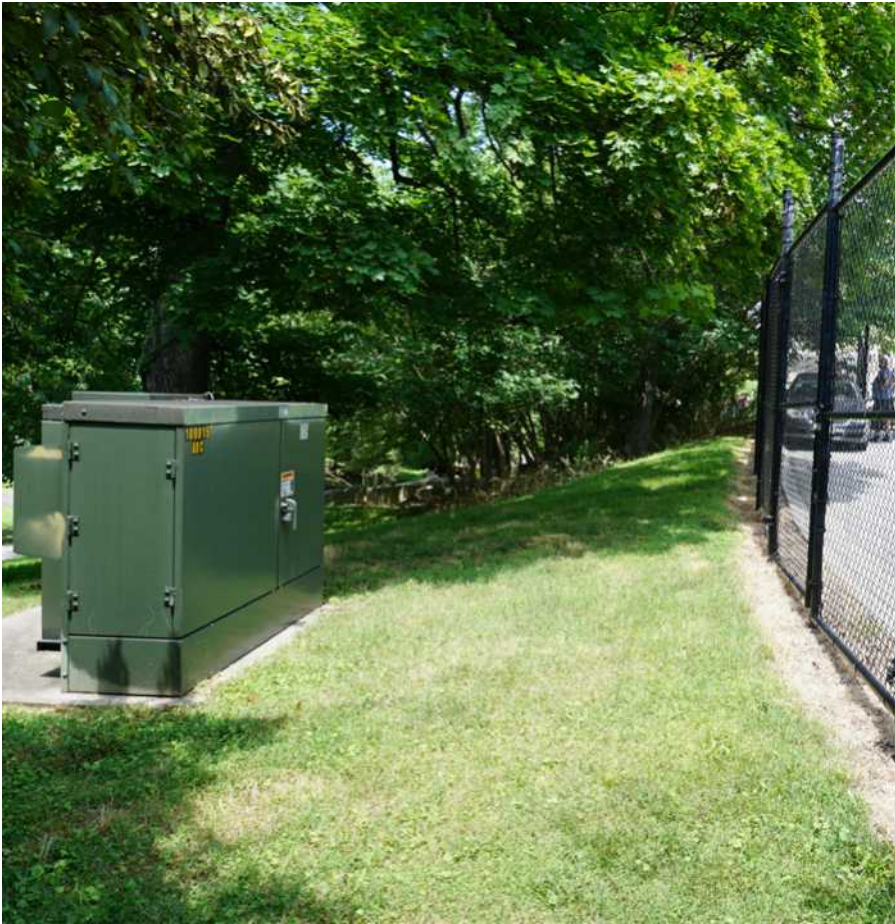
View of Gate 9A with opposing transformer.

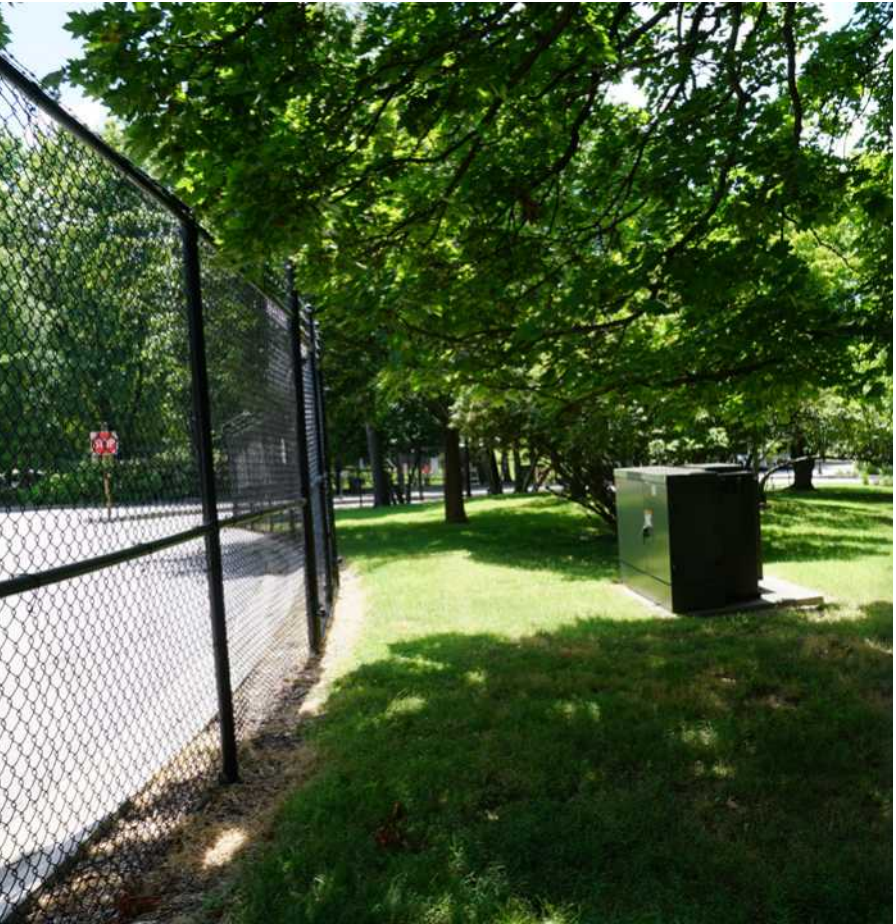
Additional view of Gate 9A with BGE transformer.

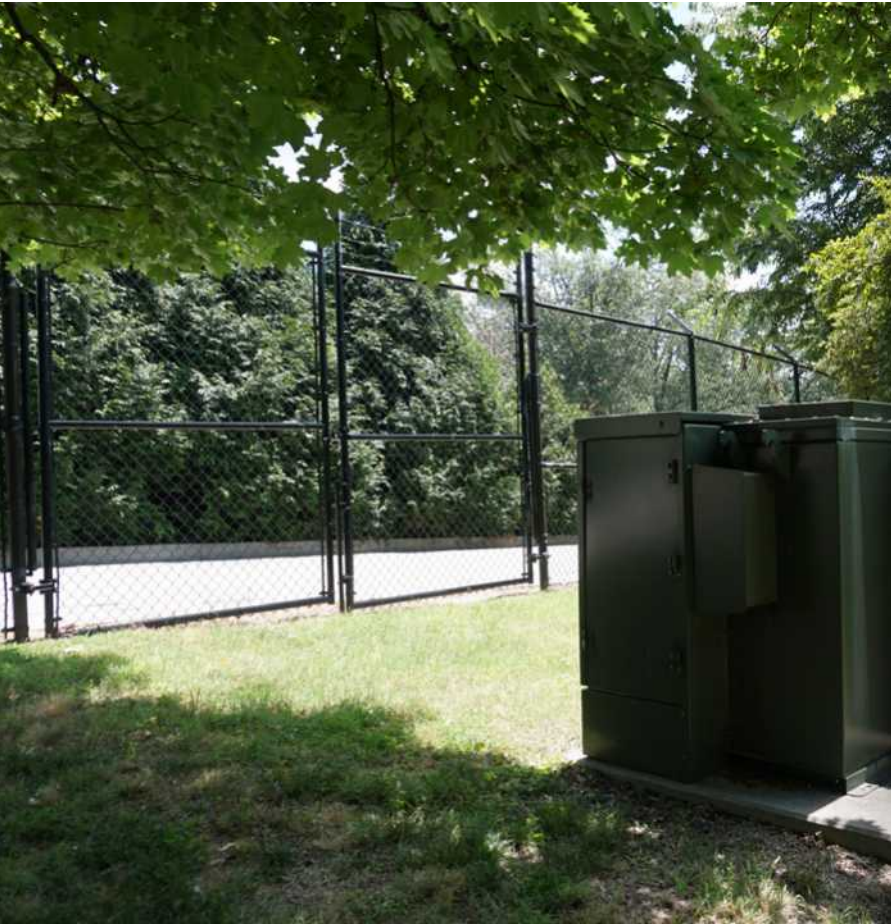
Transformer by Baltimore Gas and Electric (BGE).

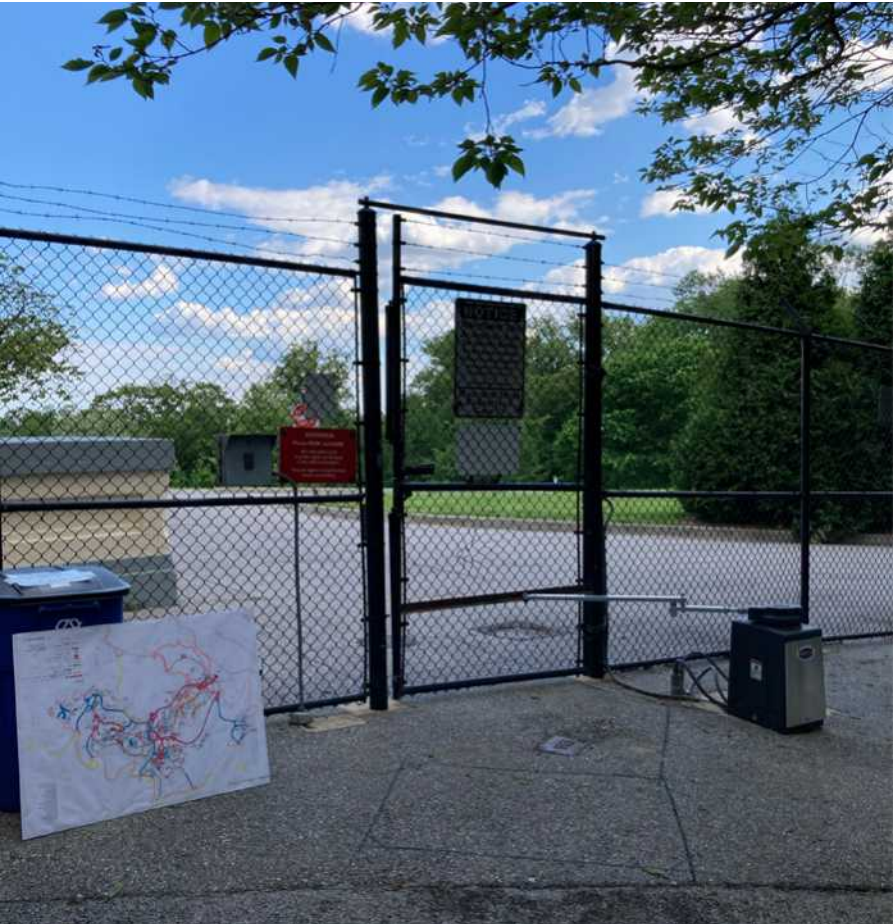
- **Gate 10**
 - Signs are outdated, new signage necessary.
 - The manual slider has a broken roller.
 - Wheel missing from gate slider.
- **Gate 11**
 - Electric coupling is broken.
 - Signs are outdated, new signage necessary.
 - Call box is not available on site, but the item is desired.

Elevation of slide Gate 11.

- ~~New sign to match "New Zoo Standard" coordinate text with Zoo.~~
- Gate 10:** Replace broken roller on manual slide gate. Coordinate product with zoo, prepare using manufacturer specifications.
- Gate 11:** Repair electric coupling mechanism. Use specifications provided by manufacturer.
- ~~Add call box. Coordinate placement and product with zoo. Set at height proposed by manufacturer.~~

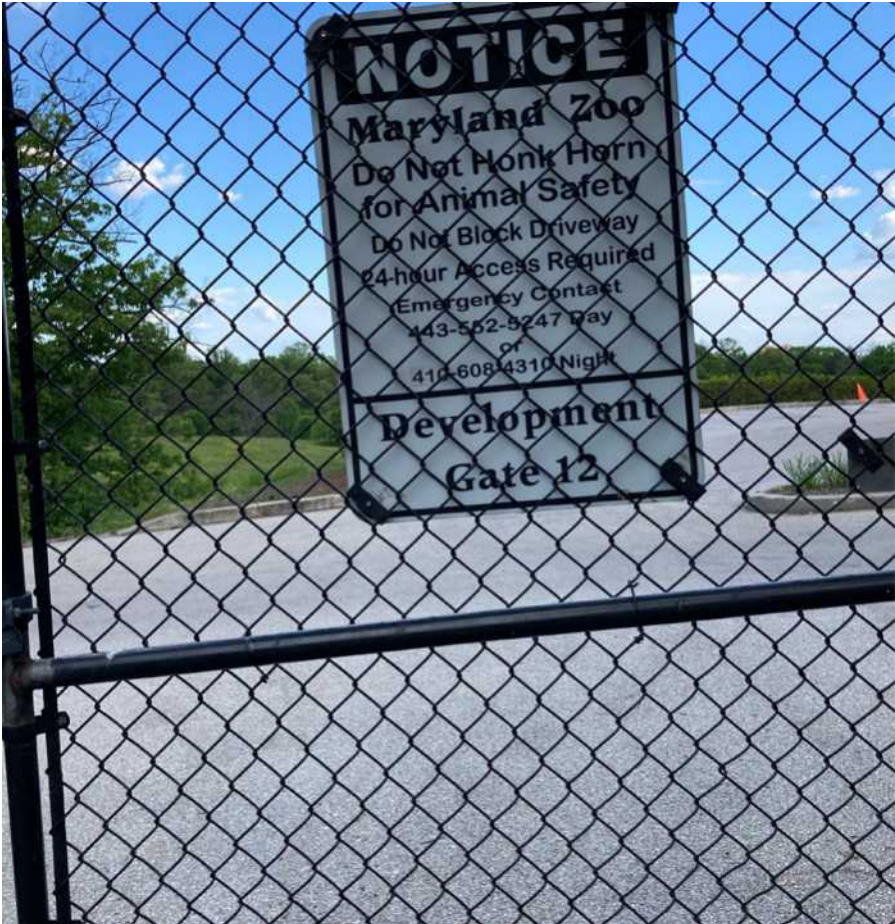
Close view of Gate 12, outdated sign.

- ~~New sign to match "New Zoo Standard" coordinate text with Zoo.~~
- Remove existing gate and keep the two support posts for use in replacement build.
- Build manual slide gate, 12 ft in length, according to zoo standard specifications. Gate should have a sheet metal skirt that sits 2" above grade when gate is closed. Skirt will match slope. (See Gate 14 for reference).
- Match skirt on Gate #14.

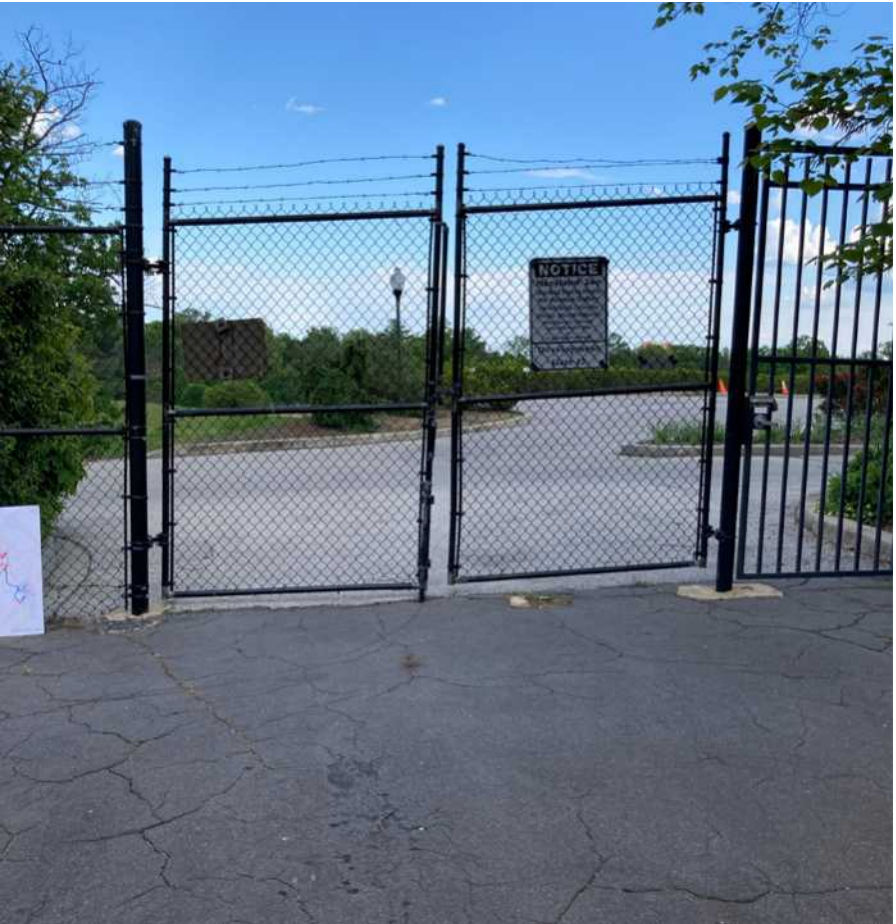
| • Gate Condition | Poor, Double Swing, 12 Ft In Length |

Elevation of double swing Gate 12.

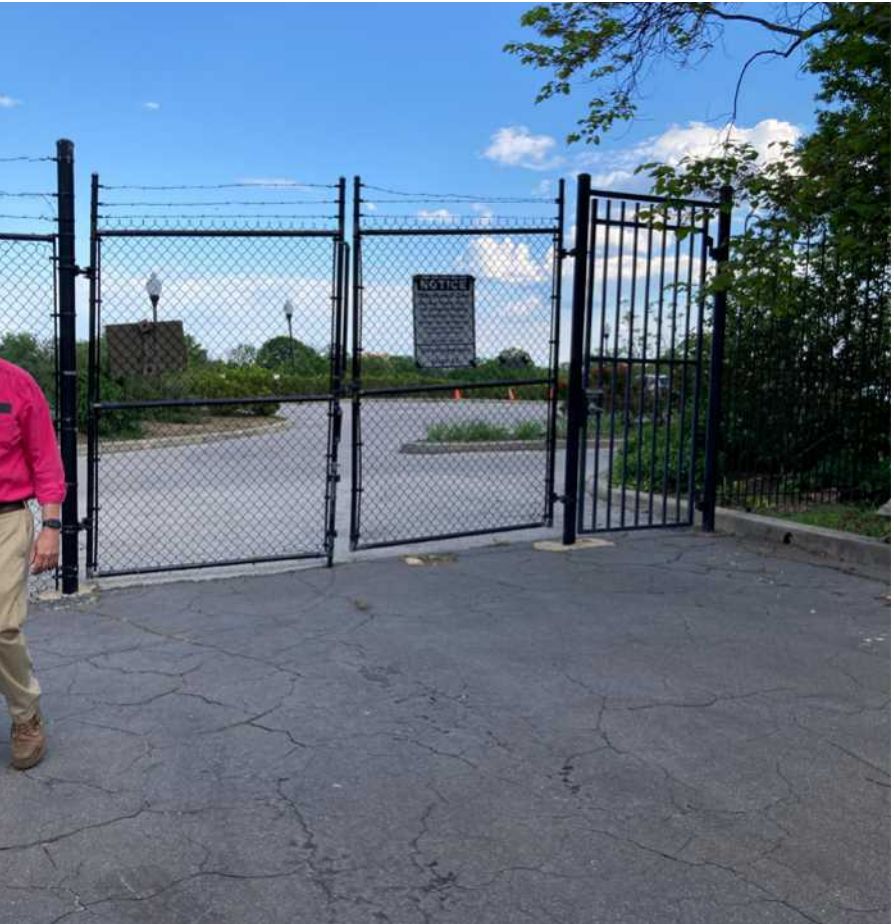
Perspective view of Gate 12. Connects to planting beds.

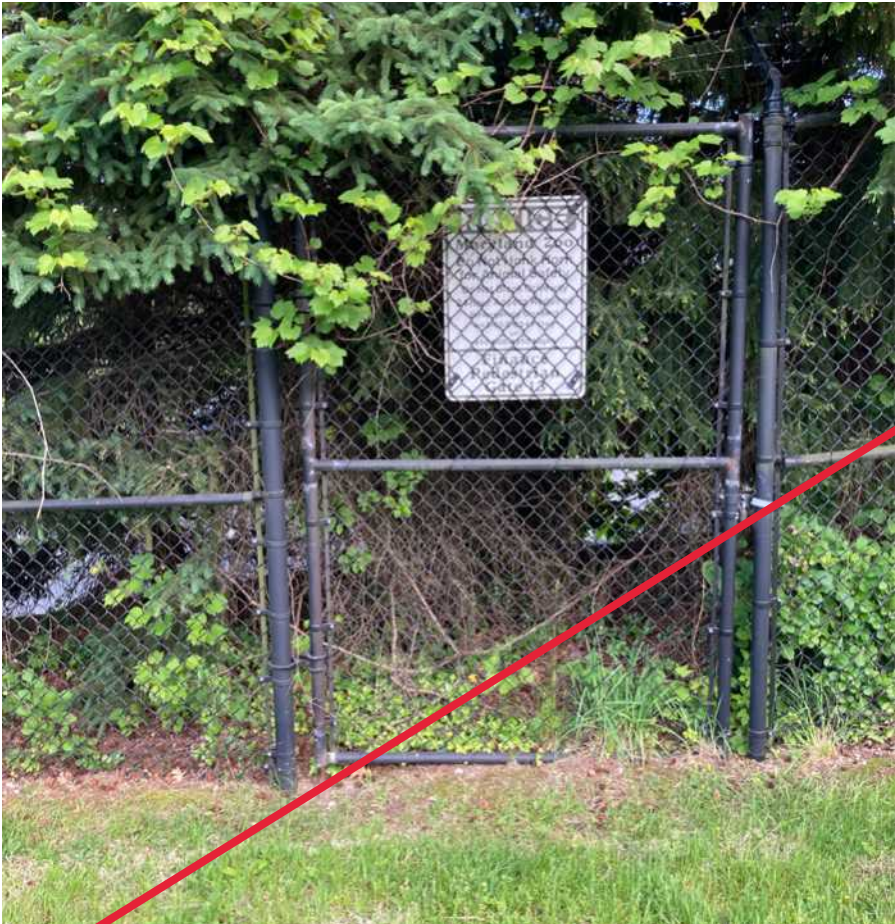
- Gate is no longer in use but does not need to be removed. Gate in Fair condition.

View of overgrown vegetation at Gate 13. No longer in use.

- No proposed changes at this time.

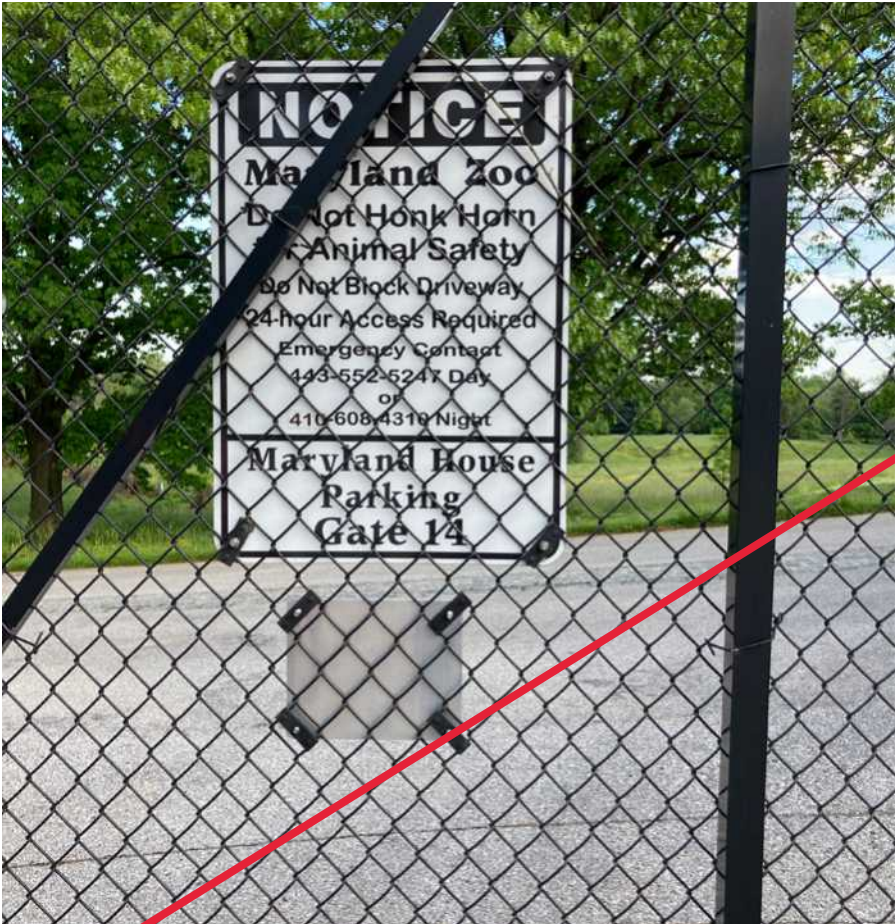
Close view of Gate 14, outdated sign.

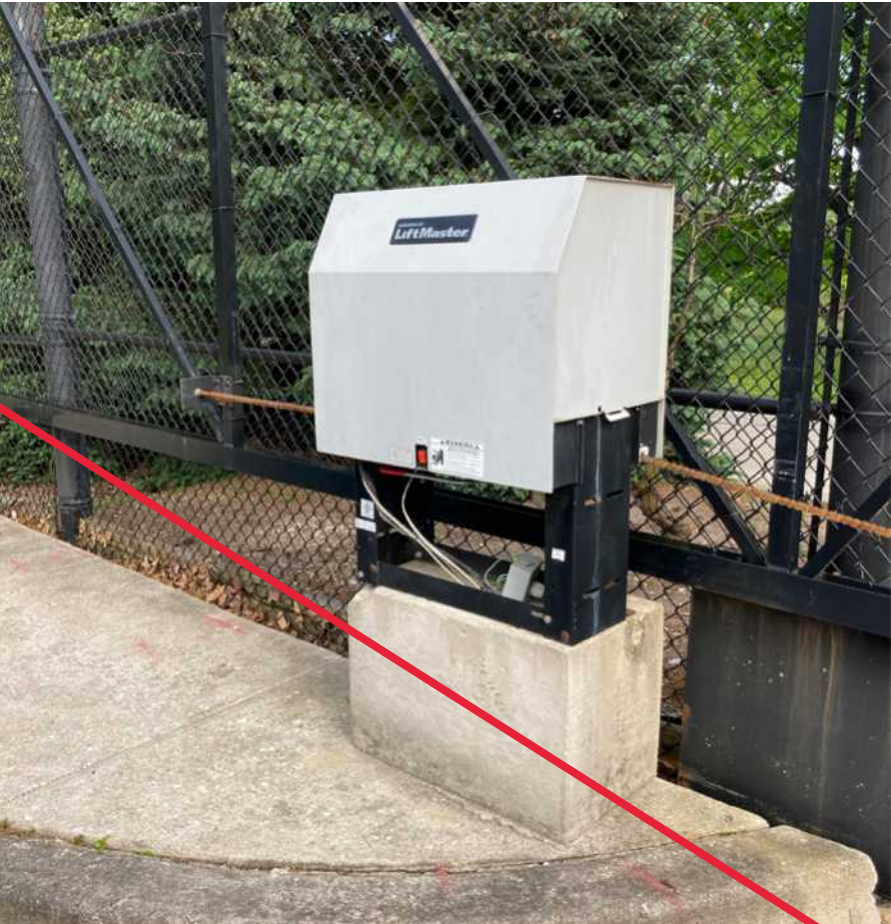
Close view of electronic coupling system at Gate 14.

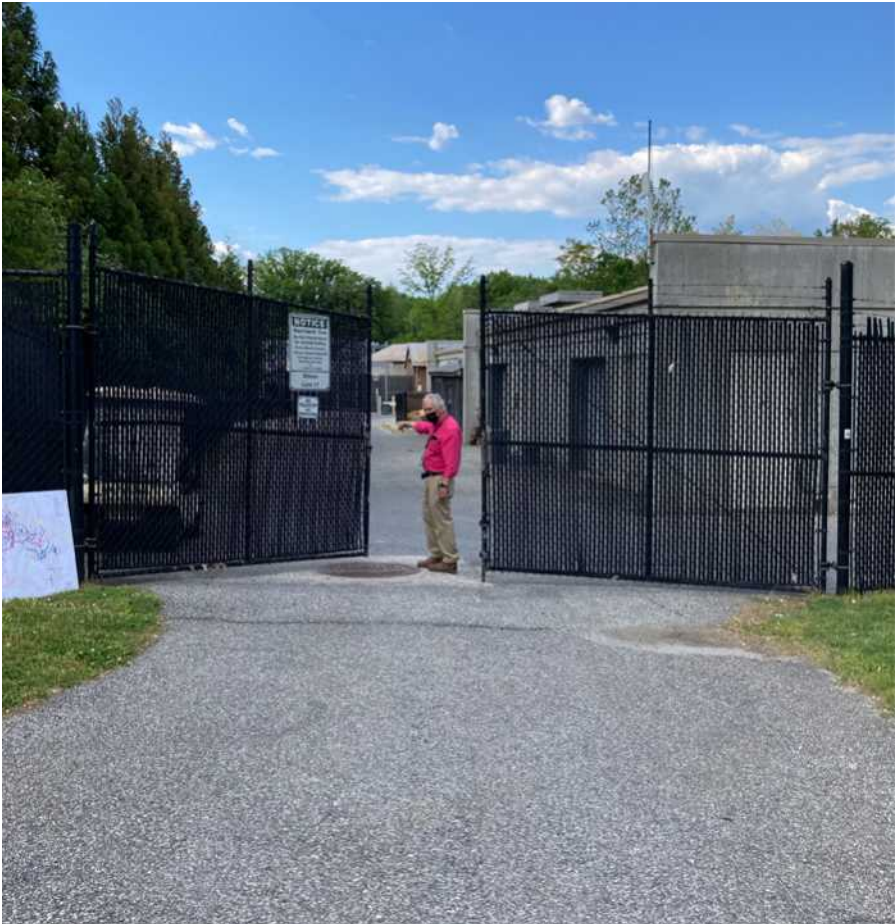
- Current gate in poor condition due to frequent use. Gate needs total rebuild.
- Signs are outdated, new signage necessary.

Elevation of double swing Gate 17.

- ~~New sign to match "New Zoo Standard" coordinate text with Zoo.~~
- Replace with black vinyl coated double swing gate, 20 ft in length.
Rebuild gate according to zoo standard specifications.

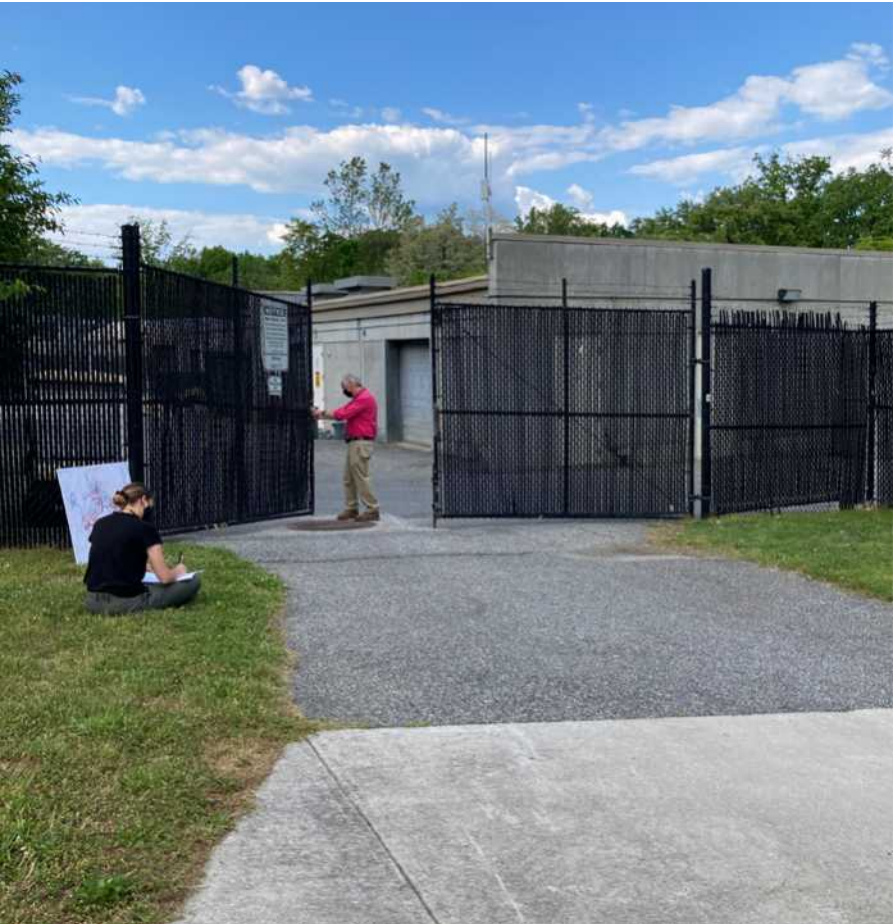
Elevation of double swing Gate 17.

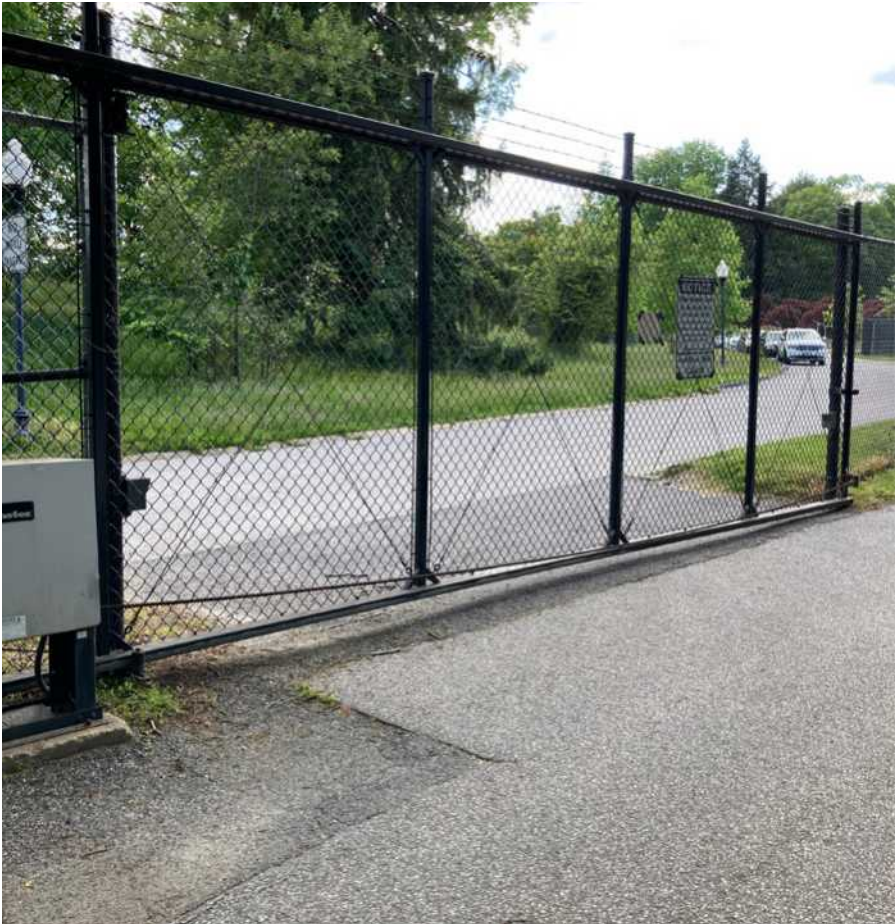
- Chain plate is broken (see image bottom right).
- Signs are outdated, new signage necessary.
- Electric mechanism needs to be repaired.
- Confirm gate has miller edge.

View of Gate 18 with electric slide opening.

- ~~New sign to match "New Zoo Standard" coordinate text with Zoo.~~
- Replace chain plate. Construct replacement using manufacturer specifications. Coordinate with zoo for product information.
- Confirm gate has miller edge. If gate does not, add miller edge to gate.
- Electric gate mechanism broken. Repair according to manufacturer specifications. Coordinate product information with zoo.

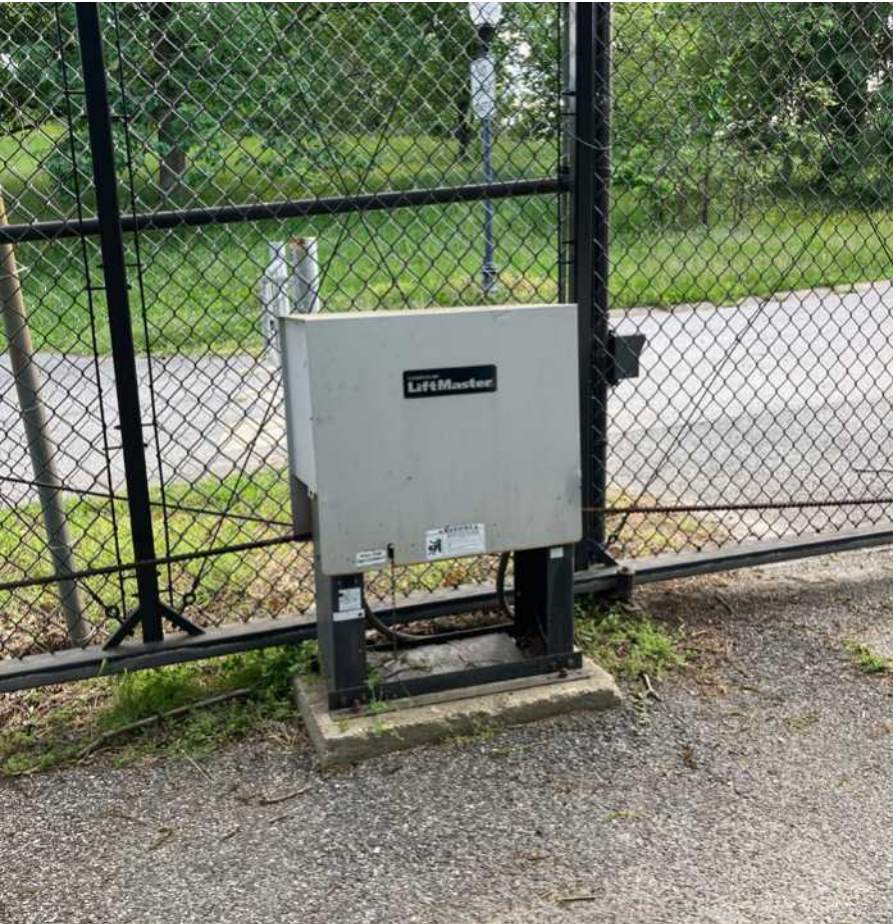
Close up of electric coupling system.

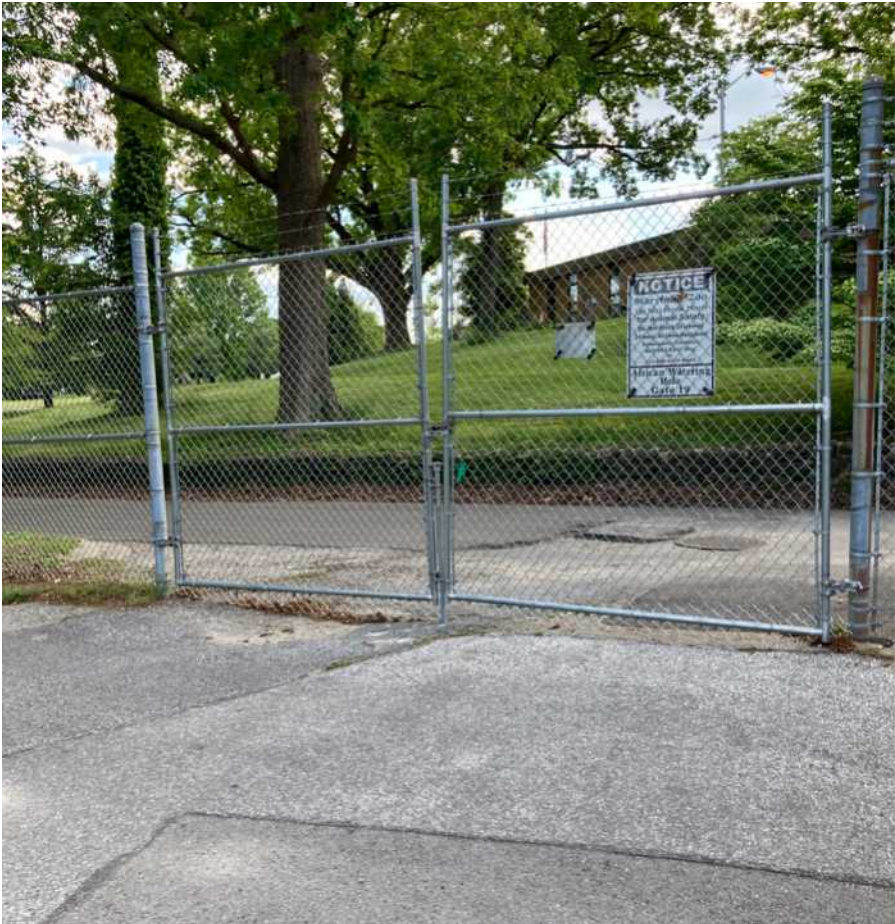
- Gate is in poor condition and needs full rebuild. Transition to slide gate is desired.
- Signs are outdated, new signage necessary.

Elevation of Gate 19.

- ~~New sign to match "New Zoo Standard" coordinate text with Zoo.~~
- Remove existing gate. Existing gate posts can be kept for transition to slide gate.
- Construct manual slide gate, 16.5 ft in length. Construct according to zoo standard specifications in attached design sheet.
- Construct manual slide gate, 16.5 ft in length. Construct according to zoo standard specifications in attached design sheet.

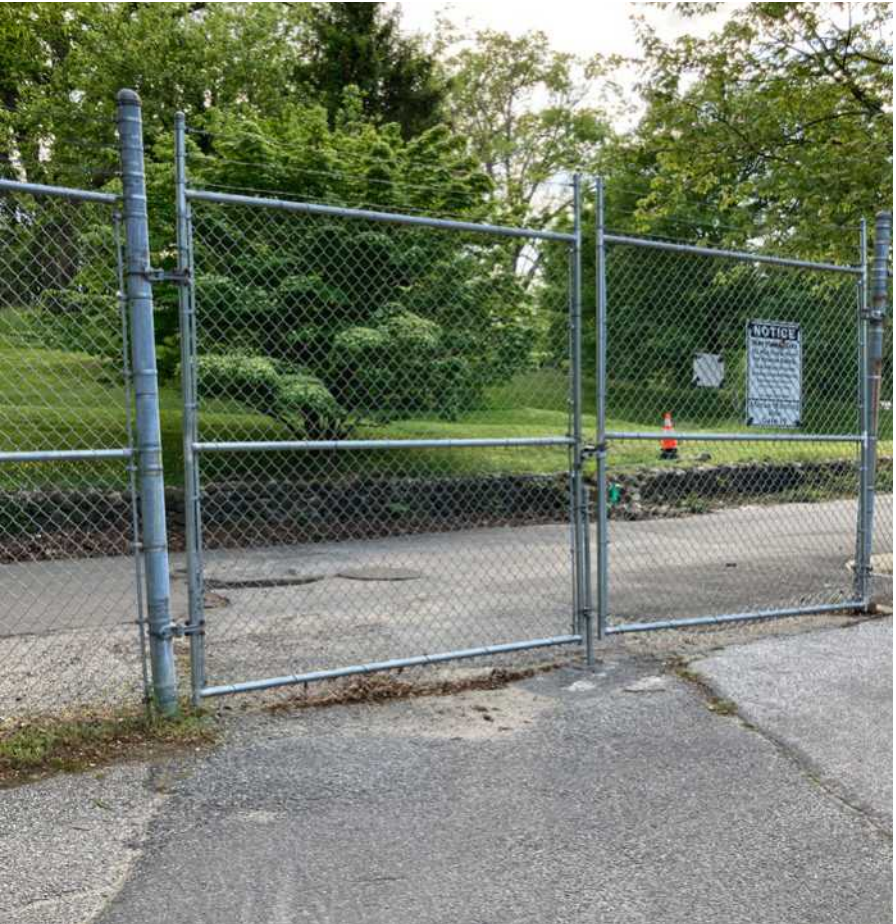
Additional elevation of Gate 19.
