THE MARYLAND ZOO IN BALTIMORE

PERIMETER GATE REPORT

SEPTEMBER 2021

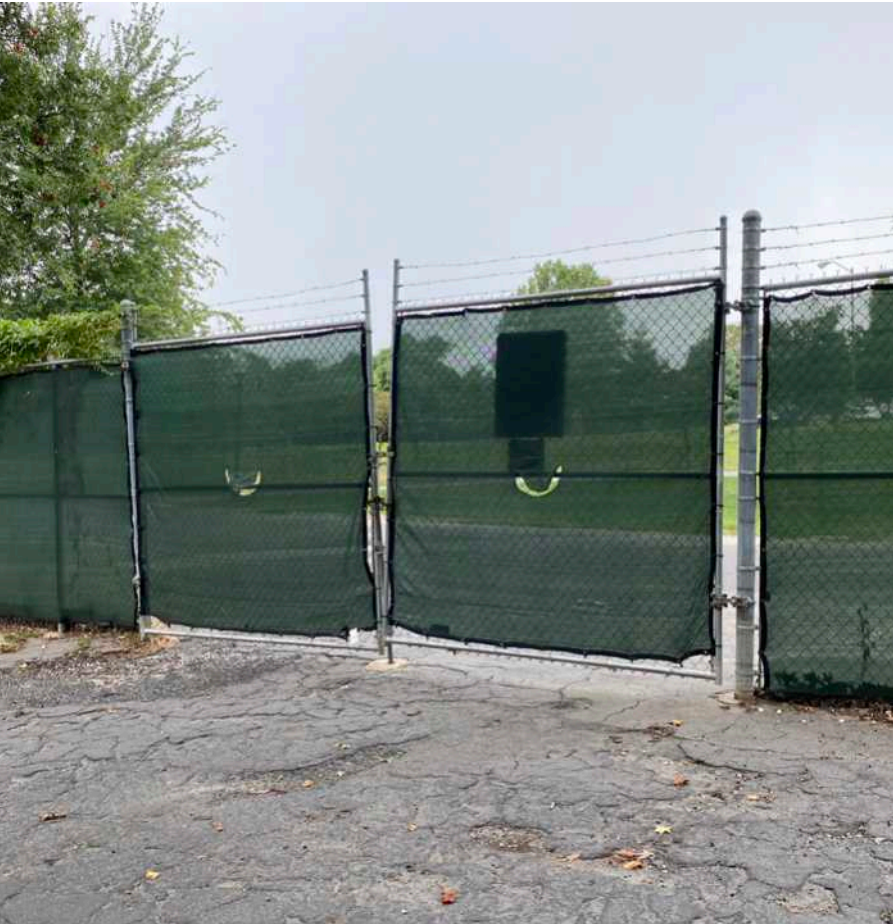
- Gate condition poor for usage type. Rebuild to slide gate is necessary.
- Signs are outdated, new signage necessary.

- Paving in poor condition, needs major repaving on interior.
- Paving should go approximately 25 feet on either side from center of gate.

Exterior view of double swing Gate 20.

- ~~New sign to match "New Zoo Standard" coordinate text with Zoo.~~
- ~~New asphalt paving. Remove old asphalt and prepare base according to MDOT standards prior to paving. New asphalt paving should be 25' on either side of gate.~~
- ~~Remove existing gate. Existing gate posts can be kept for new swing gate.~~
- ~~Construct manual swing gate, 16 ft in length. Construct according to zoo standard specifications in attached design sheet.~~

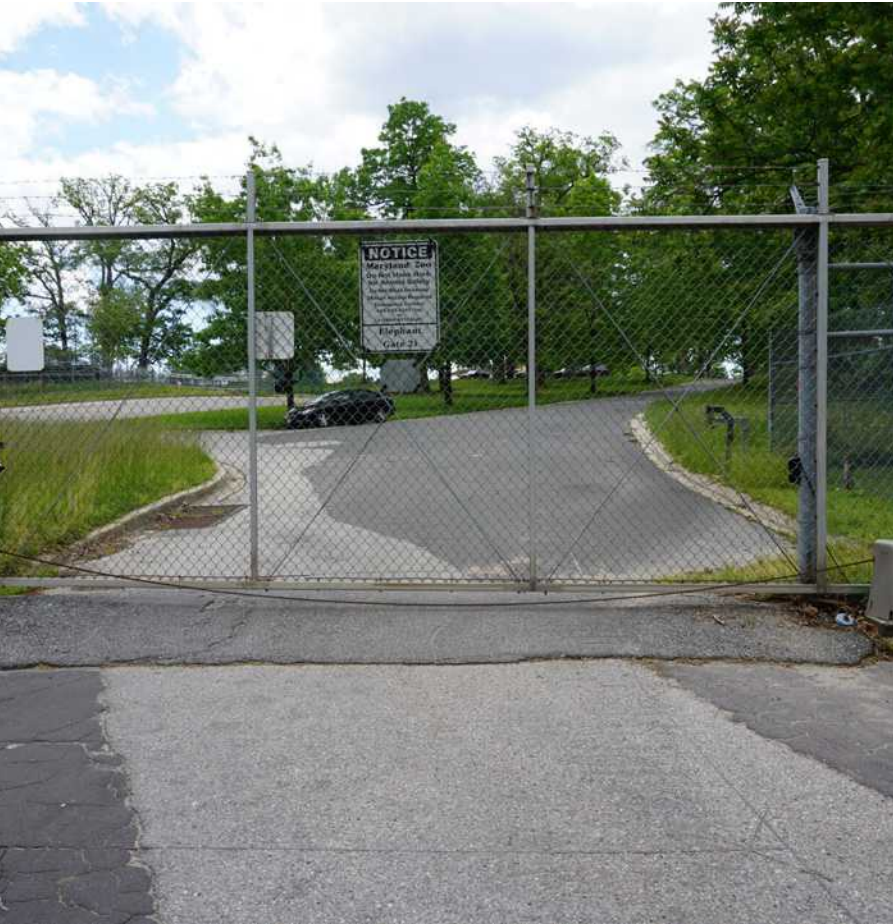
- Gate has missing guide wheel.

Elevation of slide Gate 21.

- ~~New sign to match "New Zoo Standard" coordinate text with Zoo.~~
- Replace guide wheel on gate. Coordinate product with zoo.
- Construct NEENAH 14" drain system. Use manufacturer specifications.
- ~~Add call box. Coordinate locations with zoo. Coordinate product with zoo. Set at height proposed by manufacturer.~~

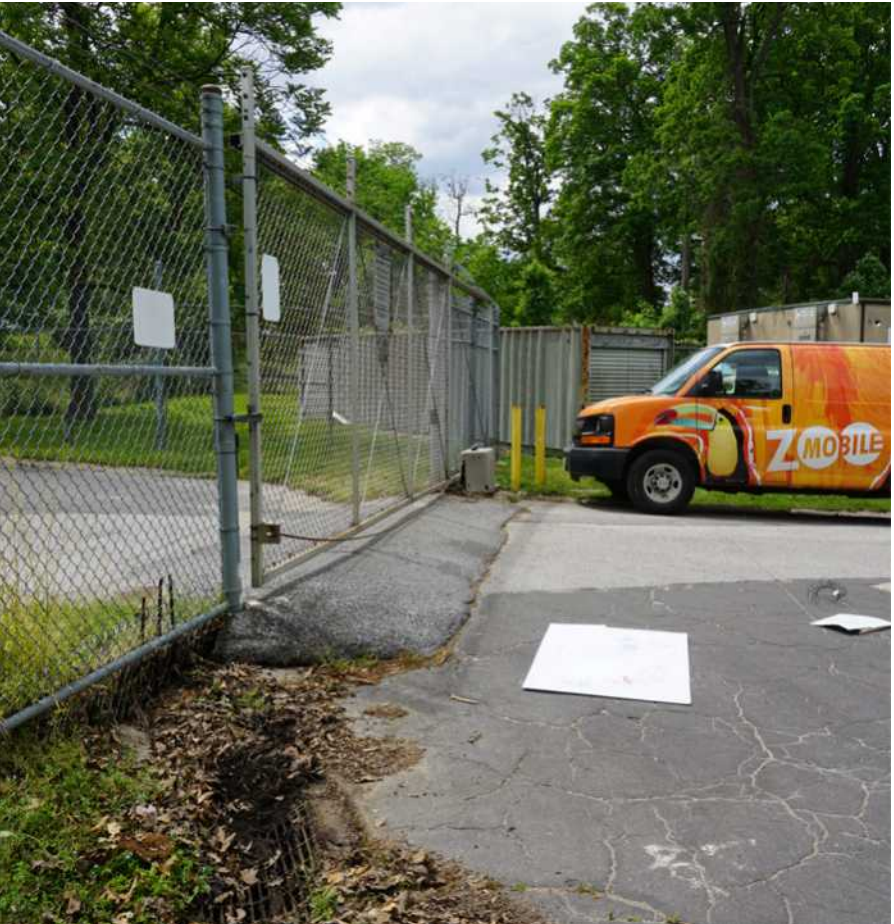
- Pavement in poor condition due to stormwater mismanagement.
- Paving in poor condition 20ft into the interior.
- Trench drain will mitigate stormwater issue, requesting NEENAH 14 in drain addition.

Curb detail view at Gate 21.

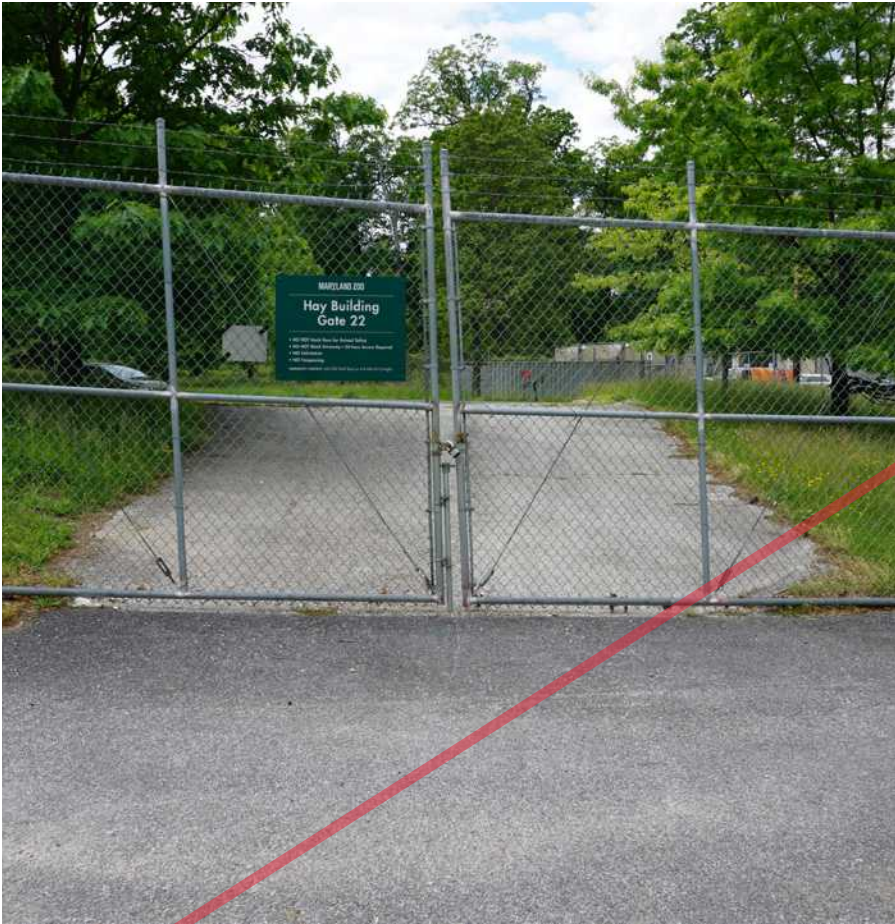
Close view of Gate 22.

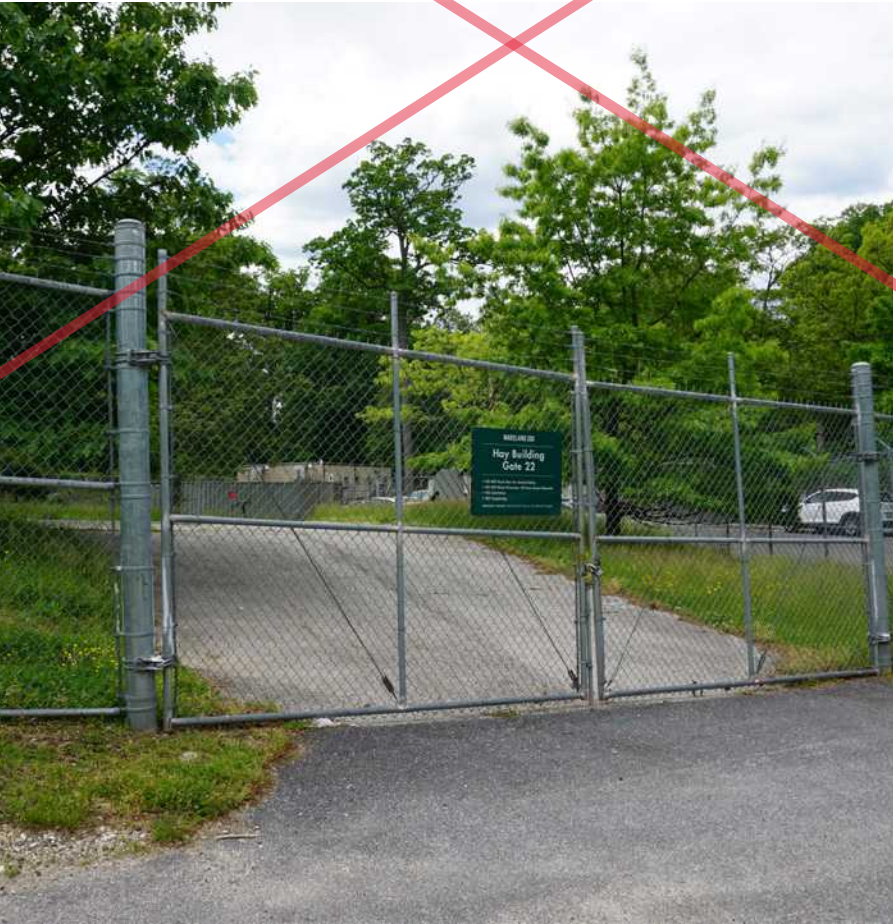
Additional view of Gate 22.

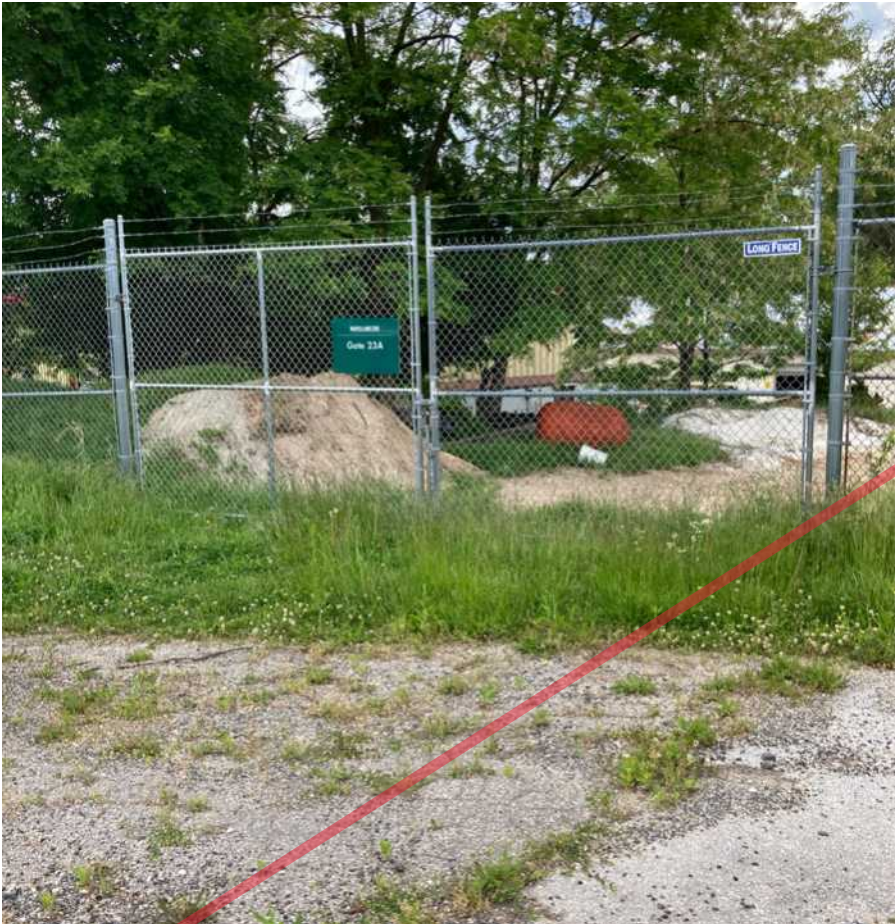
Elevation of double swing Gate 23A.

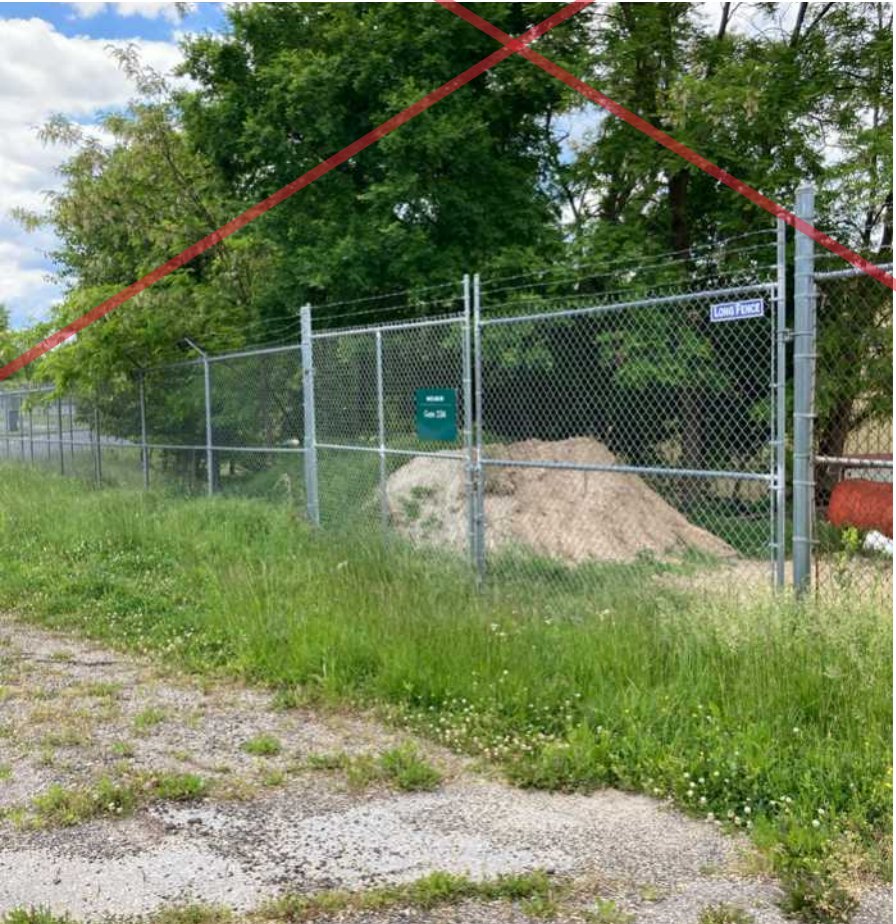
Additional view of double swing Gate 23A.

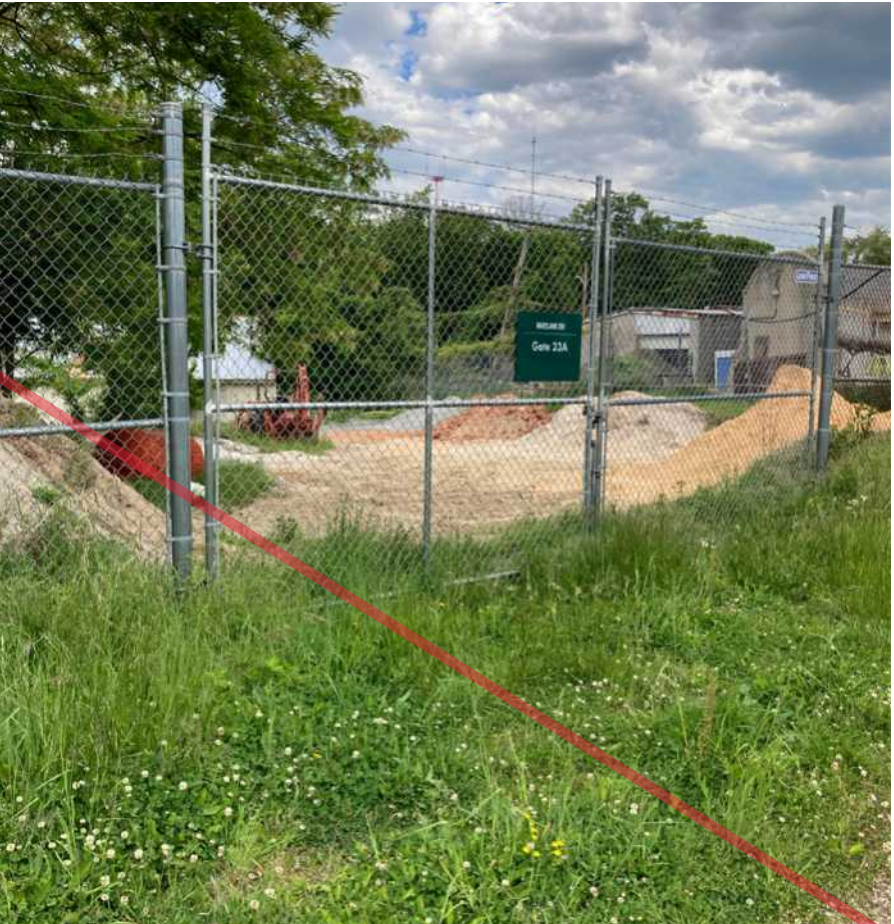
Overgrown vegetation at Gate 23A.

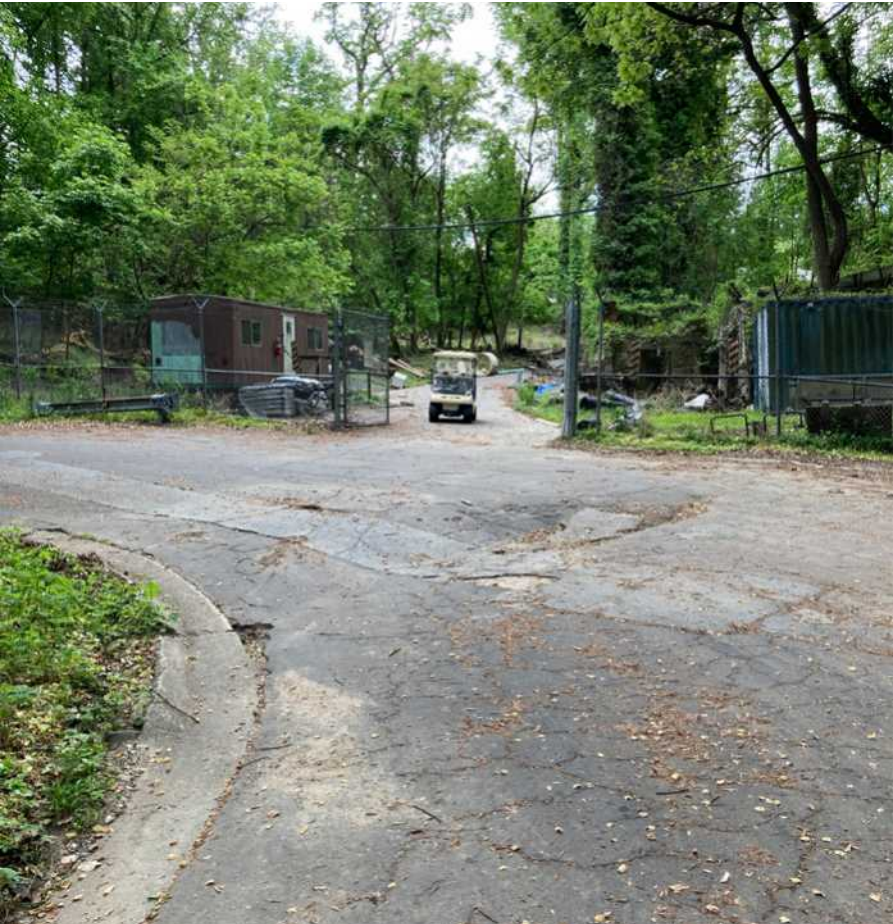
Elevation of double swing Gate 24.

- ~~New sign to match "New Zoo Standard" coordinate text with Zoo.~~
- Add drop pin to gate. Drop pin should be constructed according to zoo standard specifications in this report.
- Barbed wire on either side of gate should be replaced. Remove existing 40'-0" segment next to gate and replace according to zoo standard specifications.
- Overgrown vegetation should be completely removed within a 20'-0" radius of gate.

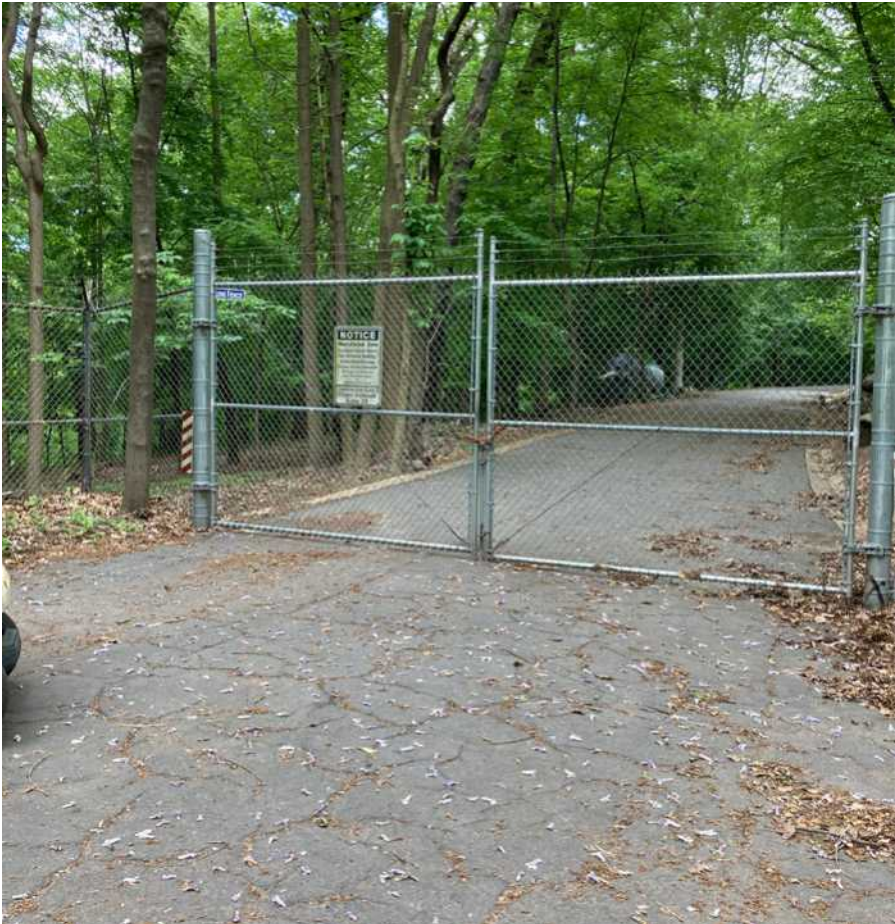
- Gate is missing drop pin.
- Signs are outdated, new signage necessary.

Elevation of double swing Gate 25.

- ~~New sign to match "New Zoo Standard" coordinate text with Zoo.~~
- ~~Add drop pin to gate. Drop pin should be constructed according to zoo standard specifications in this report.~~
- Remove princess tree from gate area. Tree removal method should not damage existing gate. Coordinate removal with zoo.
- Remove all vegetation and leaf debris within a 20'-0" radius of gate.

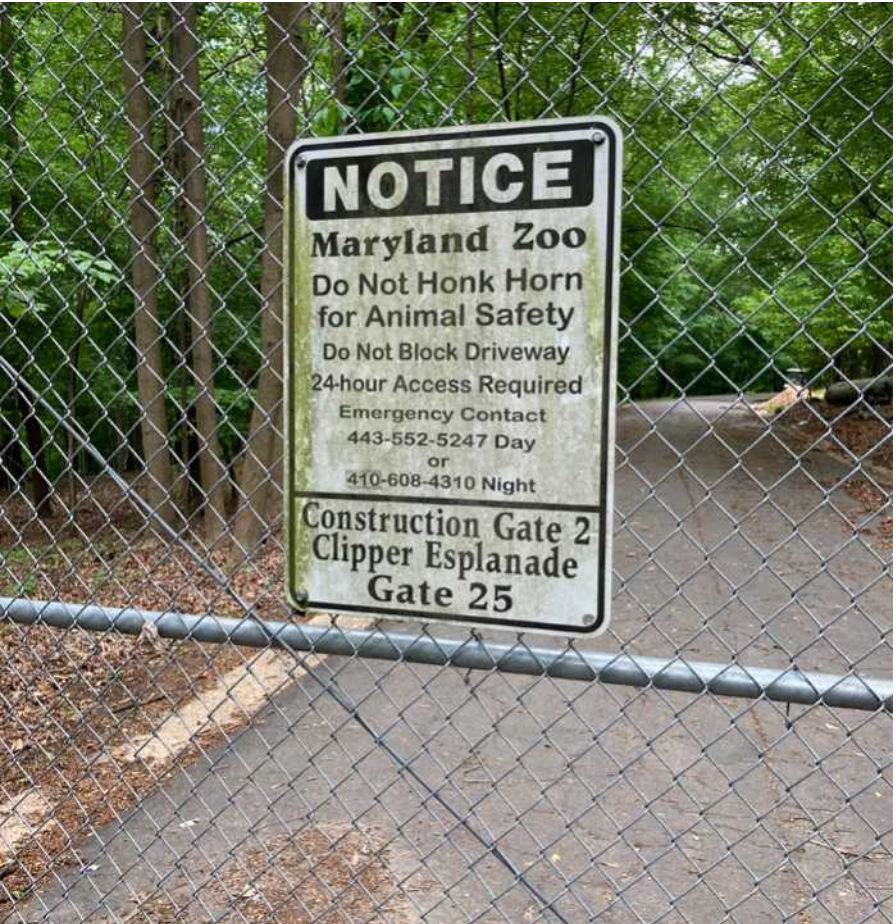
Close view of Gate 25, outdated sign.

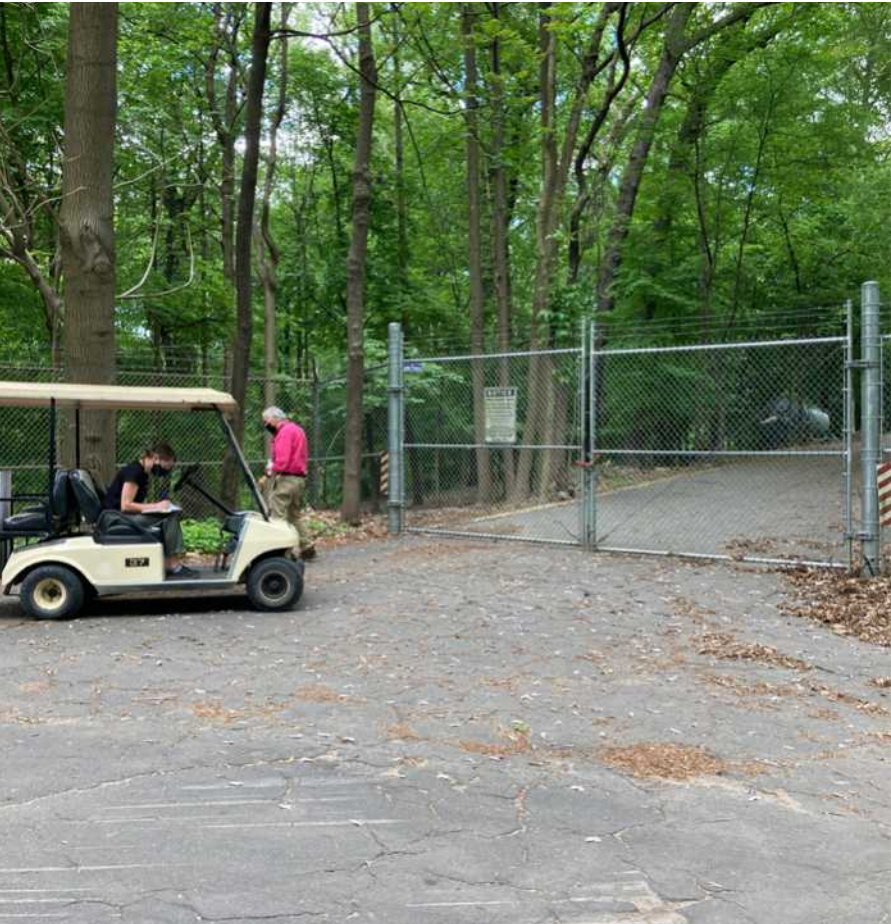
- Unchecked tree growth. Princess tree (located exterior right of gate, from interior view) needs to be removed.
- Ruderal growth has left site messy with leaf debris.

Additional view of Gate 25.

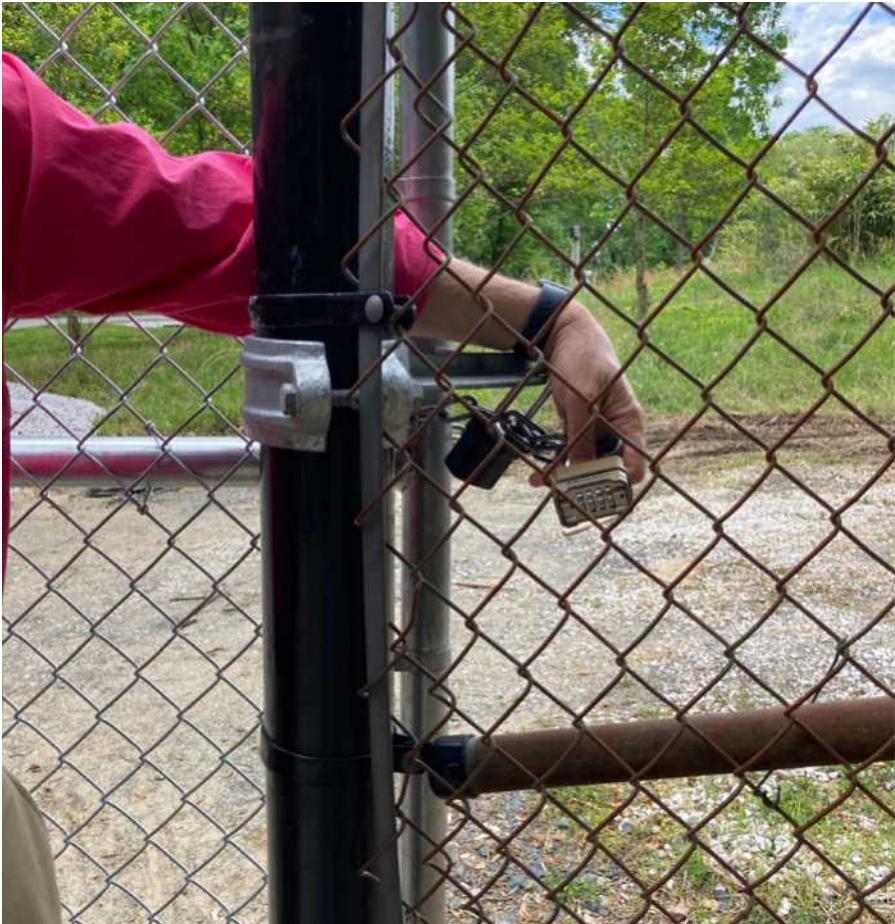
Close view of Gate 26 lock. New locking system necessary.

- ~~New sign to match "New Zoo Standard" coordinate text with Zoo.~~
- Add new locking mechanism to gate. Provide "reach through padlock" and coordinate product and placement with zoo.
- ~~Add gate skirt.~~

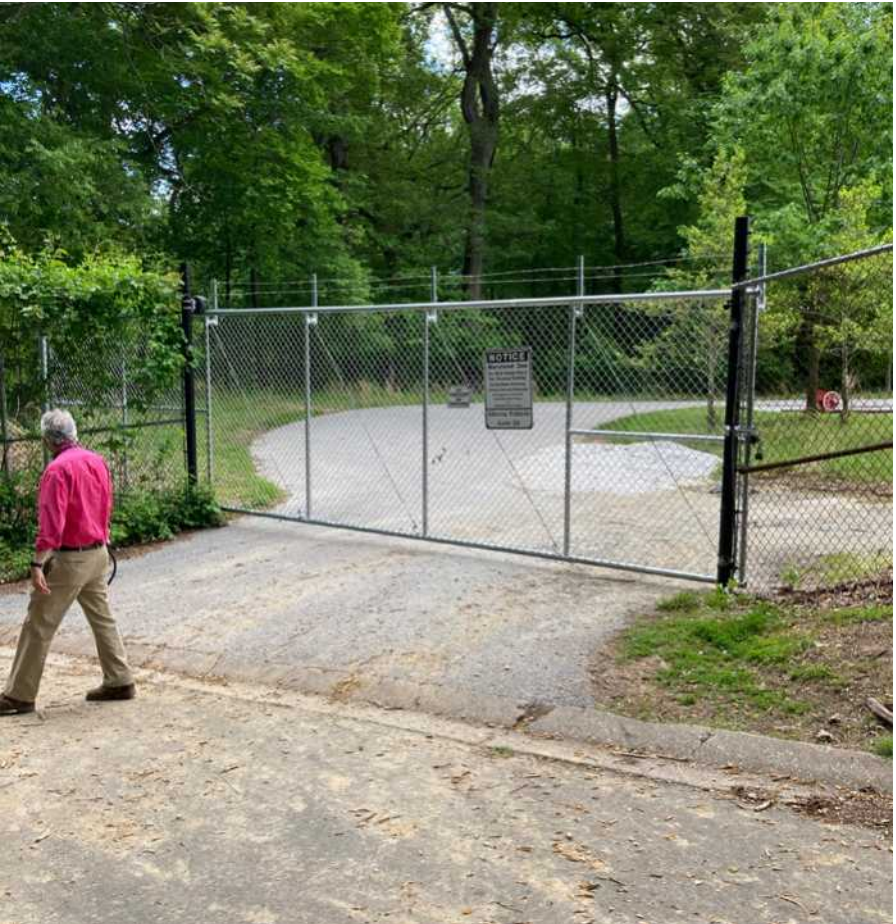
Elevation of swing Gate 26, curb for leveling.

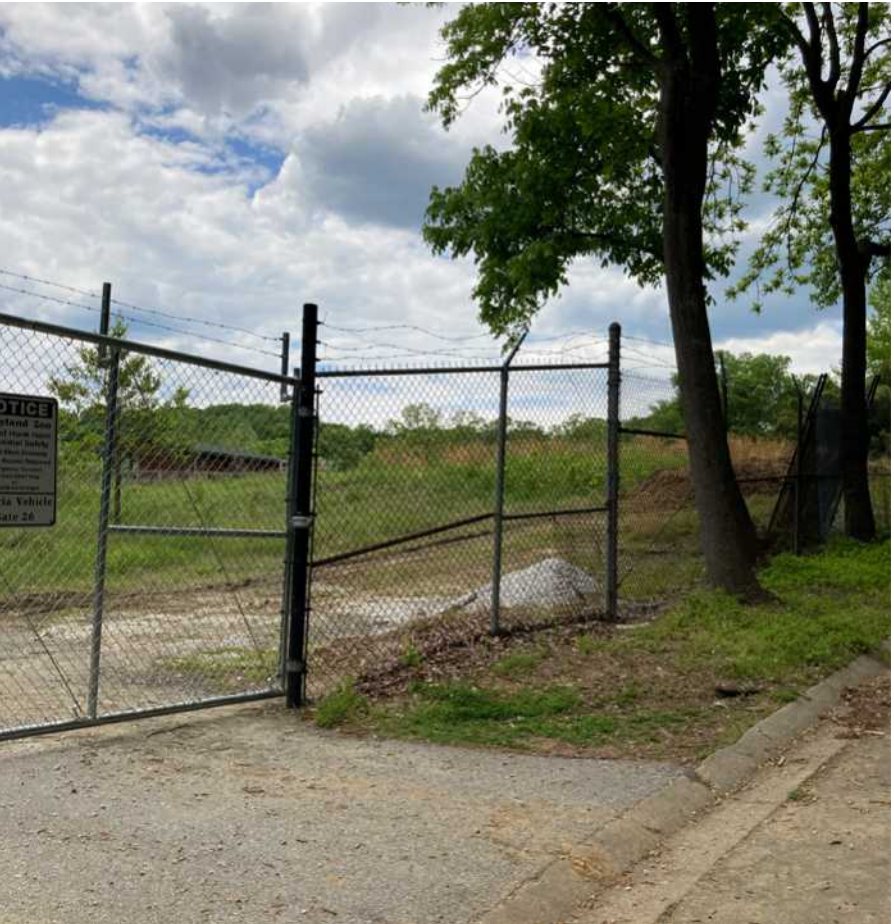
Fencing in disrepair, needs replacing.

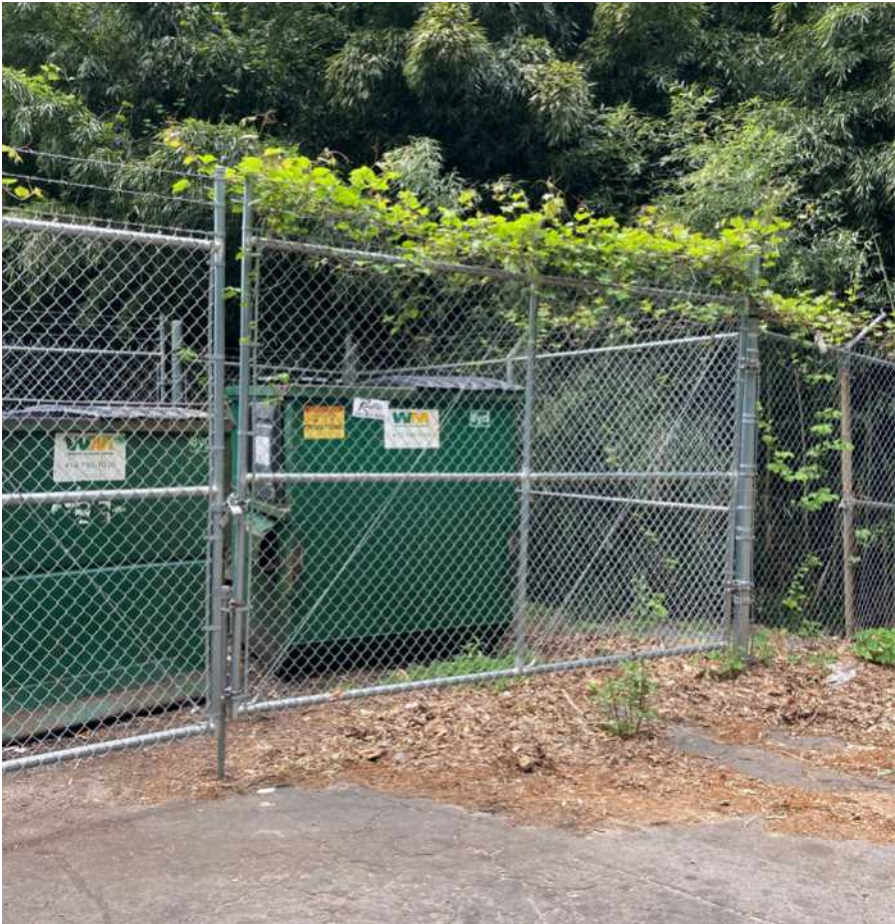
- Vegetation is very overgrown. Needs to be cleaned from the gate.

Close view of Gate 27 with vegetation to be cleared.

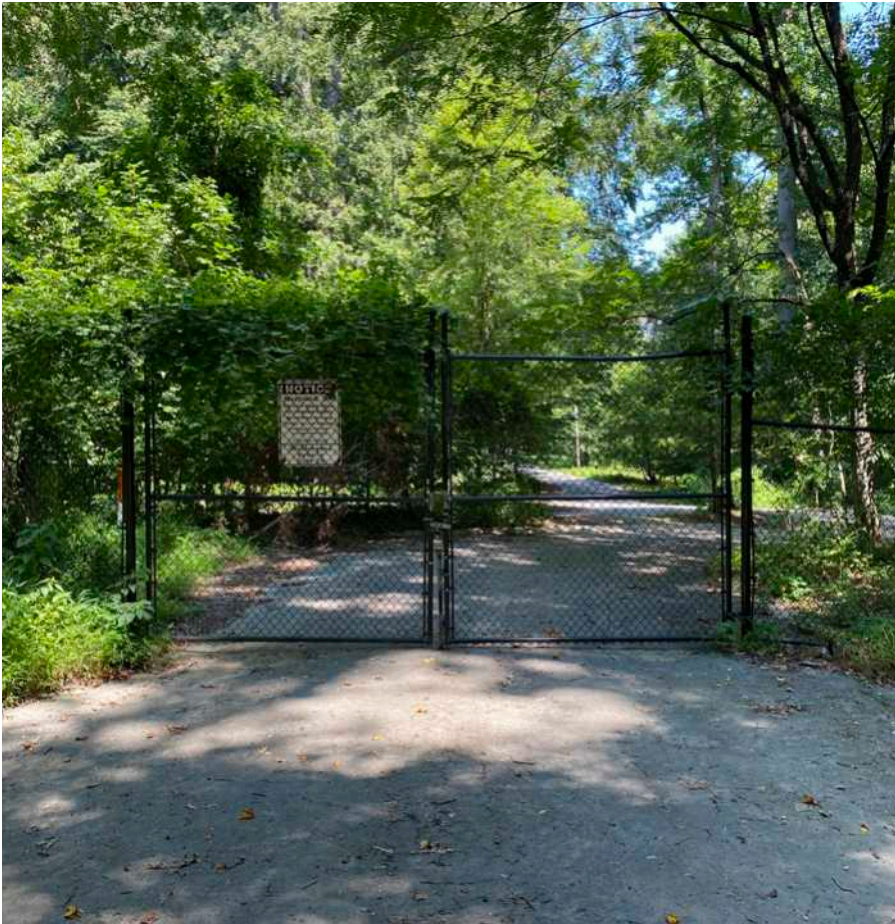
- Current gate in Poor condition

Exterior view of Gate 28.

- ~~New sign to match "New Zoo Standard" coordinate text with Zoo.~~
- New 22 ft black vinyl coated manual swing gate.
- Remove existing concrete footers.
- Patch asphalt where needed.

clean vegetation
30' radius of gate

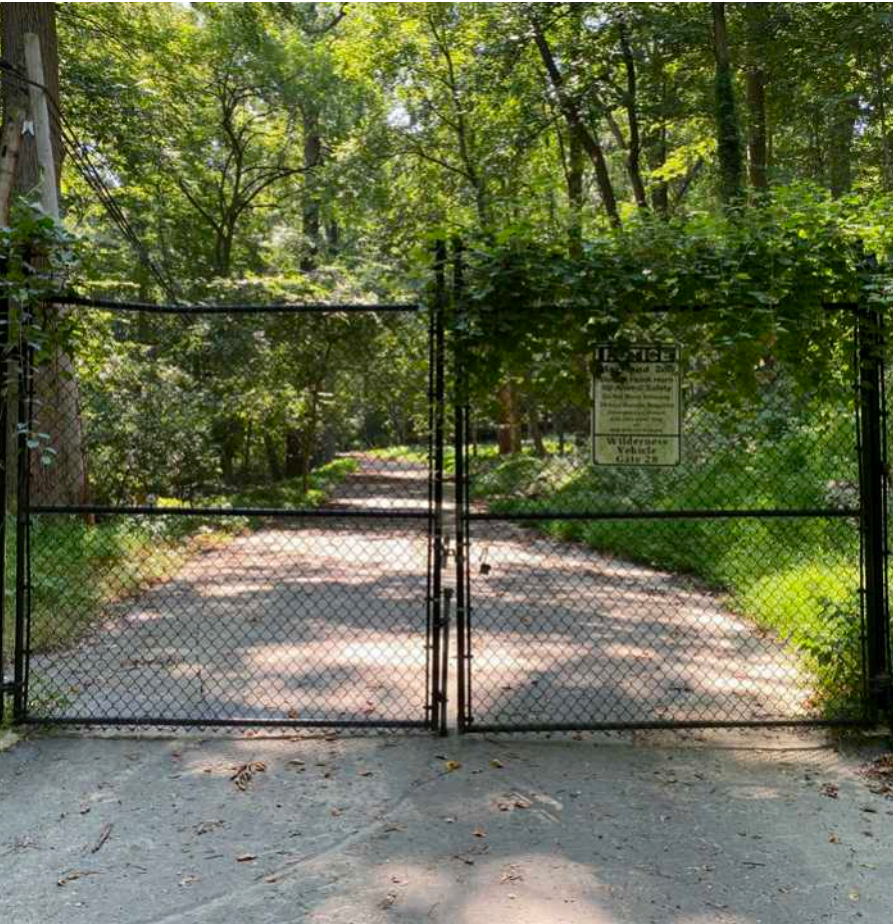
Exterior view of double swing Gate 28.
